Client Name: **Jonathan & Winlyn Aguila**

ROOF INSPECTION

Property Address: **132 Cafeto Ct, Walnut Creek, CA 94598**
Inspection Date: 2/18/2026 Inspector: **John Quintal** Lic. 690049

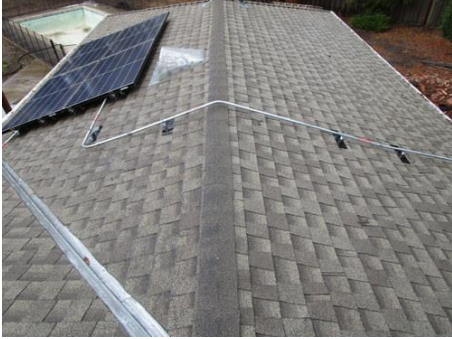
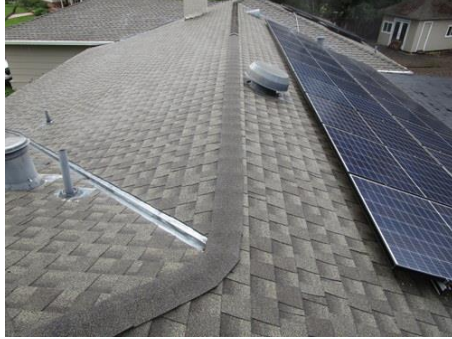
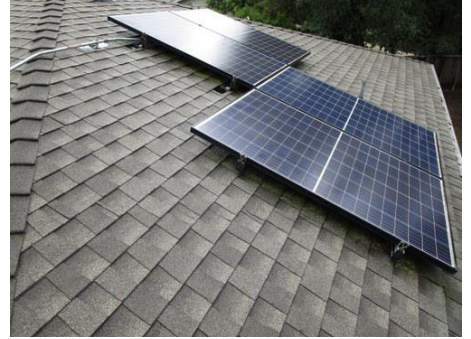
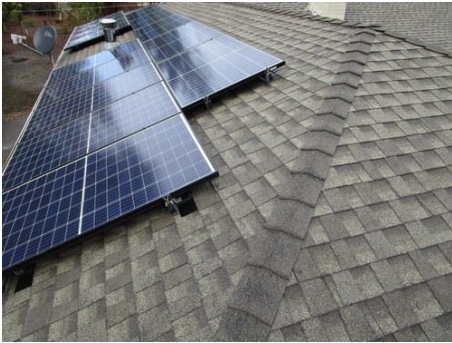
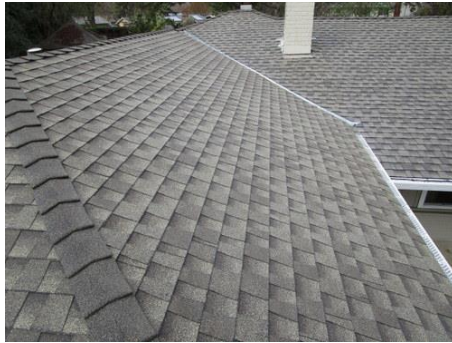
- 1. Overviews of the current conditions of the roof and its related components.** The condition of the roof concealed under solar panels is unknown and not within the scope of this inspection.

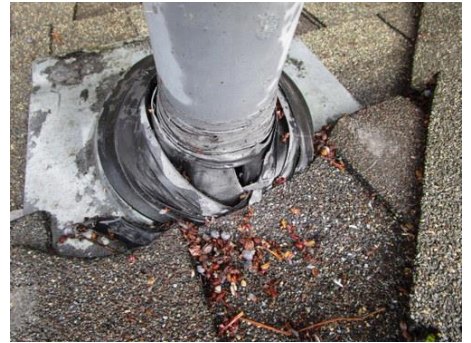
ITEM 2

- The main electrical mast has open voids where the mast penetrates through the rubber coupler that can allow water entry and damage to the eave below.
Recommendation: Repair open voids at the electrical mast.

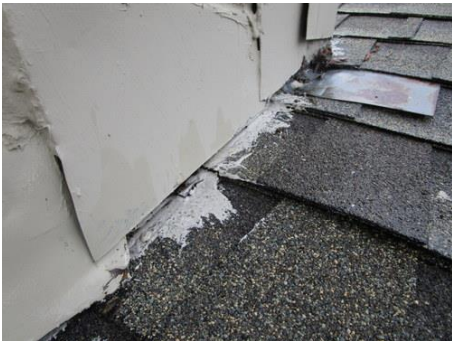
ITEM 3

- Elastomeric coating or sealant has been used around the base of the chimney for unknown reasons. The visible portions of the flashings appear serviceable. If any leakage has occurred below this area, we recommend removing sealant and flashings as needed to repair the area. The sealant appears intact at this time.

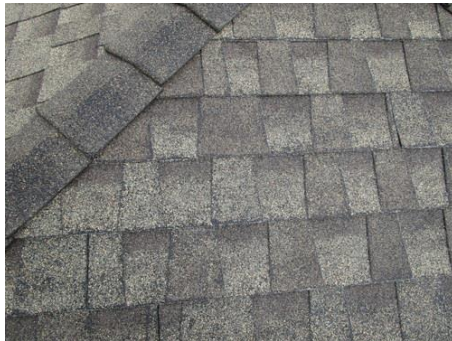
ITEM 4

- At the southern/western facing exposures, there are field, hip, and ridge shingles that have moderate granule loss. Excessive granule displacement can reveal the underlying components of the shingle such as the fiberglass scrim. Saturation of these components may allow moisture influence beneath the roof during periods of heavy rain.

It is reasonable to believe that some of these shingles may need further granular surfacing added within the next few years as part of maintenance. Much of this granular displacement appears to be due to foot traffic during the installation of the solar panels. We recommend having these areas of the roof re-inspected in the next few years for possible replacement or adding granular surfacing.

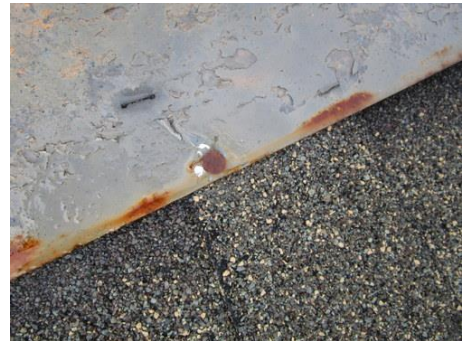
ITEM 5

- There are several exposed nails at flashings that may allow water entry.
Recommendation: Seal all exposed fasteners.
