## Solid Ground Construction

**RE: 132 Cafeto Court, Walnut Creek, CA**

### **SUMMARY OF FINDINGS**

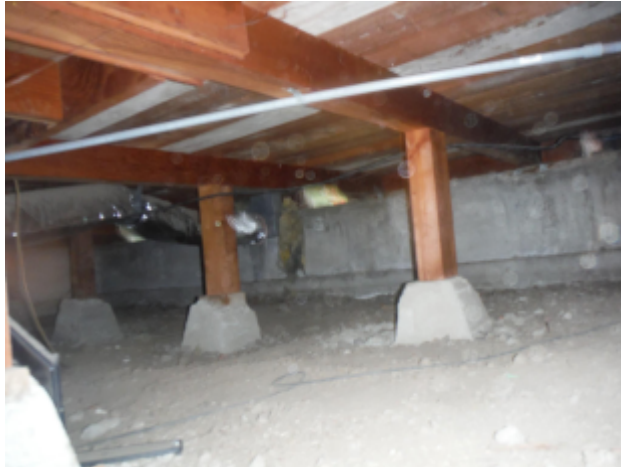
The results of the floor level survey indicate that the original foundation and the majority of the floors throughout the original portion of the residence are relatively level, at or within the standard tolerance. There is one area at the right-front of the original structure where the elevation of the floor is higher and slightly over the standard tolerance, and this unevenness is noticeable when walking the floor. Since it does not involve the perimeter foundation, the floor in this area can be lowered to a more even plane with the surrounding floors by making adjustments to the under-floor pier posts. I have included an estimate for this work below.

Area under uneven floor at right-front of original structure

- Modify the existing 12 wood pier posts under the right-front portion of the residence, adding adjustable metal levelers to the posts and lowering the floor, as needed, to improve the appearance of unevenness as much as possible.

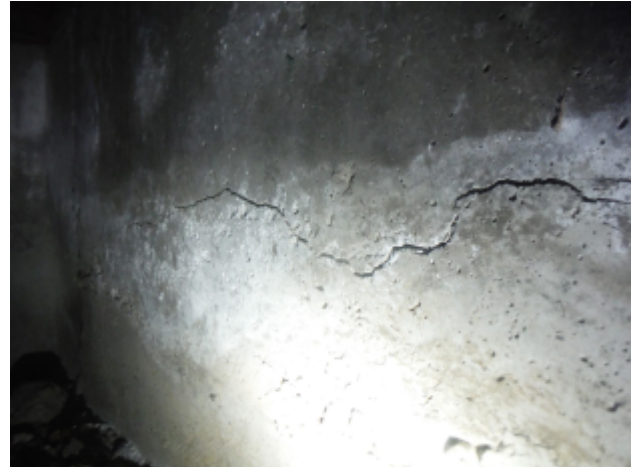
My inspection of the foundation revealed horizontal cracking along two sections under the original structure; one at the left-front, which is approximately 6 feet long, and the other at the center-rear, which is approximately 8 feet long. This kind of cracking is typically caused by the rusting and expansion of the reinforcing steel inside the foundation, and it usually happens when, during construction, the reinforcing steel is placed too close to the inner or outer surface, where it is more prone to the effects of moisture exposure/absorption.

One of two horizontal cracks in the original foundation

One method of repair would be to partially demolish these sections of the foundation, replace the steel, then re-build the foundation. But, in my opinion, based on the size of the cracks, which are open 1/4 of an inch or less, these sections of the foundation can be repaired by applying carbon fiber mesh with epoxy, which would both seal the cracks and reinforce the strength of foundation. I have included an estimate for this work below.

- Obtain repair specifications from a structural engineer. (Engineering fees are included.)
- Seal and reinforce the sections of cracked foundation at the left-front and center-rear of the original structure, using carbon fiber straps epoxied in place, in accordance with engineering specifications and manufacturer's application instructions.

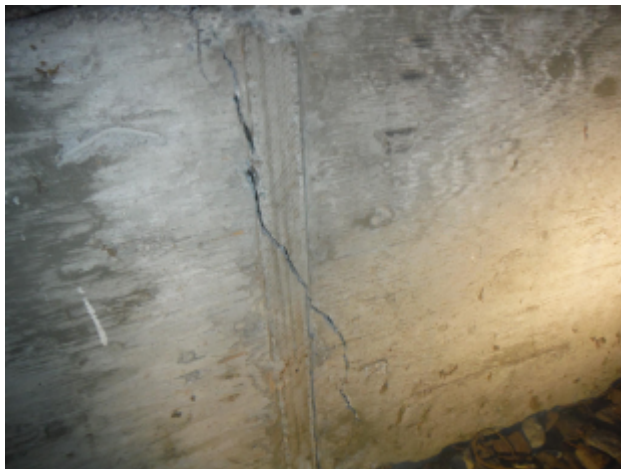
I also noted three small vertical cracks in the foundation; two at the right side of the original structure, and one at the rear of the right-rear addition. While these cracks are less than 1/4 of an inch wide and do not present a structural problem, they should be patched and braced to prevent further separation. I have included an estimate for this repair below.

One of three vertical cracks in the foundation

- Repair the three vertical cracks in the foundation at the right side of the original structure and rear of the right-rear addition by filling each with concrete mortar mix and bracing with metal straps installed across each crack, as needed, to prevent further separation.

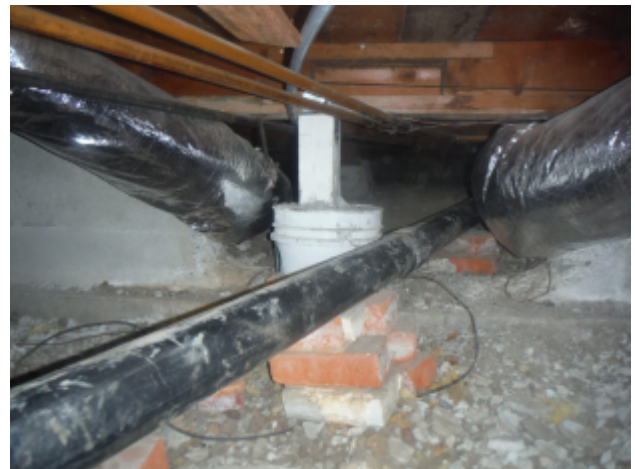
Access clearance in the area under the right-rear addition is less than standard and this area is very difficult to crawl. The access opening through the foundation wall is also restricted by plumbing and ductwork and an added pier support under the mudsill. Improving access to this area would involve cutting or chipping away more of the concrete foundation to enlarge the access opening, then

Restricted clearance at access to right-rear addition

- Enlarge the access opening in the foundation between the original structure and right-rear addition by removing more concrete from the side of the existing opening, as needed, and patching with concrete mortar mix to seal any exposed reinforcing steel.

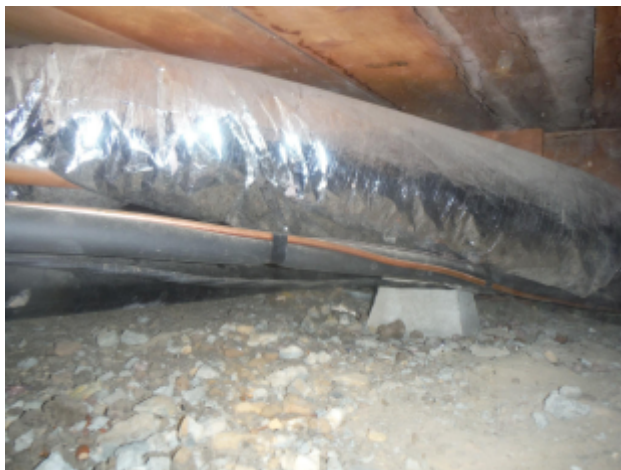
excavating 4-6 inches of soil from underneath the entire addition to increase the size of the crawl space. I have included an estimate for this work below.

Restricted clearance under right-rear addition

- Excavate and remove 4-6 inches of soil from the area beneath the right-rear addition to provide adequate crawl space access throughout. Container fee for soil disposal is included.

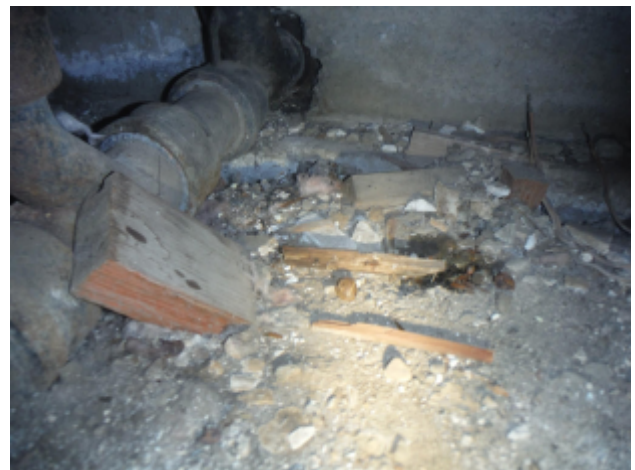
While inspecting the under-floor crawl space, I also noted cellulose (wood) debris in various locations. This debris should be removed for termite protection, and I have included an estimate for this work below.

Example of cellulose debris in the crawl space

- Remove and dispose of all cellulose (wood) debris from the under-floor crawl space.
