**SUMMARY**  
132 Cafeto Ct, Walnut Creek, CA  
94598  
Stephanie Talyat  
02/18/2026

Forest Davis  
Forest Property Inspections  
+15102623229  
[info@forestpropertyinspections.com](mailto:info@forestpropertyinspections.com)

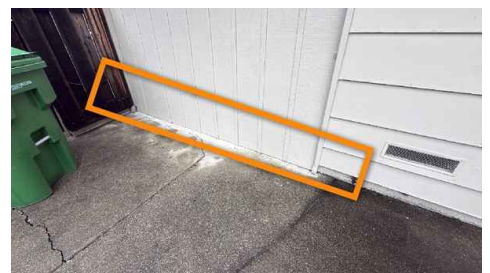
Left Garage

2.1.4 Wall Covering  
**WOOD ROT**

Wood rot discovered on wall covering during inspection. This indicates moisture damage. Recommend evaluation and repair.

Recommendation  
Contact a qualified siding specialist.

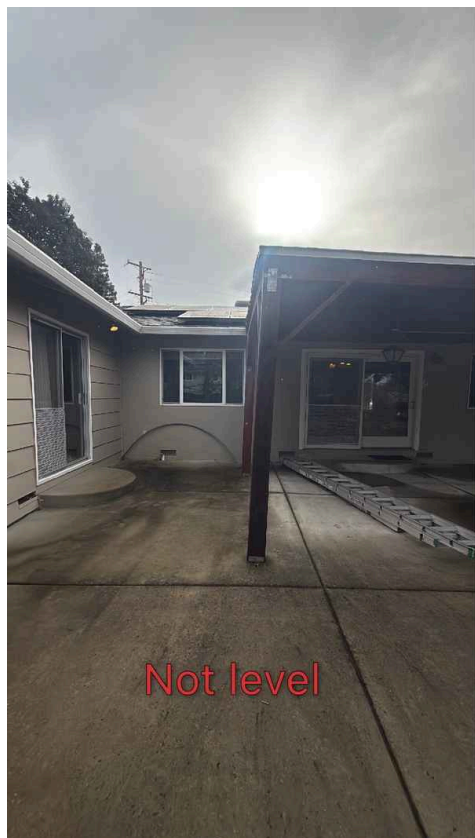
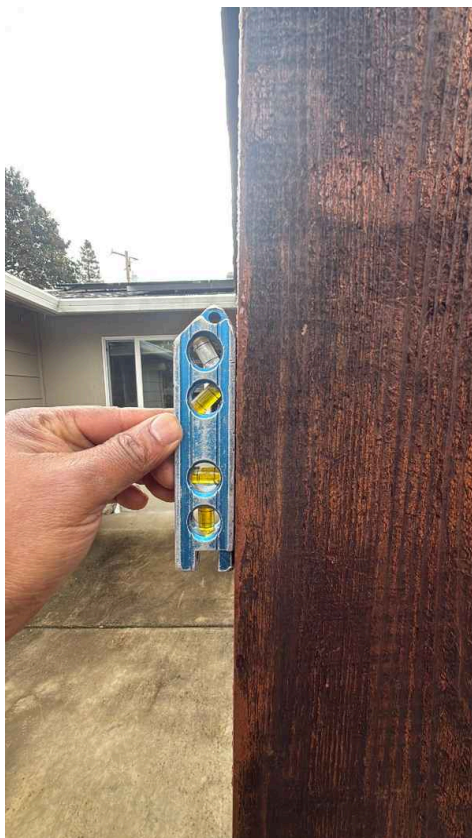
Rear

2.4.1 Decks, Balconies, Porches & Steps  
**UNSAFE COVERING**

Unsafe covering was observed. Recommend repair or replacement.

Recommendation  
Contact a qualified carpenter.

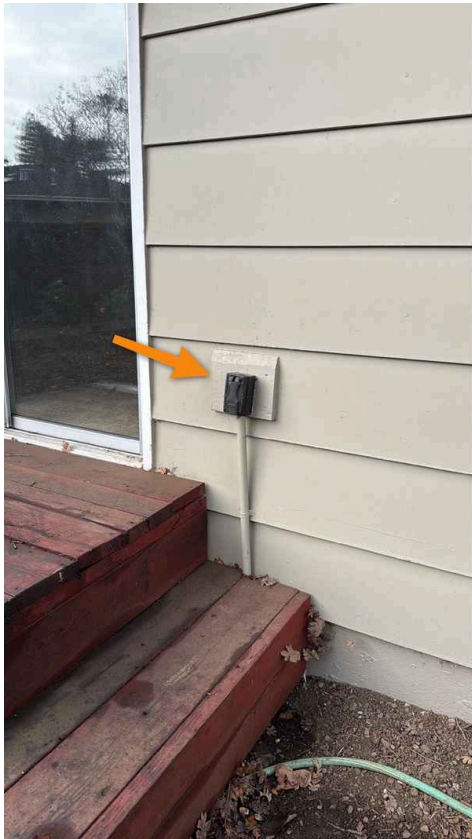
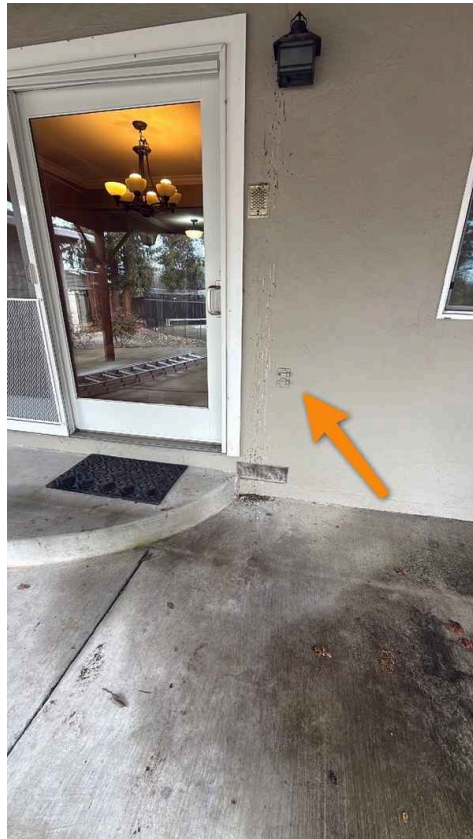
### 2.9.1 Exterior Lighting Fixtures, Fans, Switches, & Receptacles

#### **GFCI MISSING**

No GFCI protection was present in some locations. GFCIs are recommended in kitchens, baths, garages, and exterior applications. I recommend a licensed electrician upgrade by installing ground fault receptacles in all necessary locations.

**Or have an electrician identify the circuit, feeding the exterior outlets and replace the circuit breaker with a GFCI rated circuit breaker.**

Contact a qualified electrical contractor.

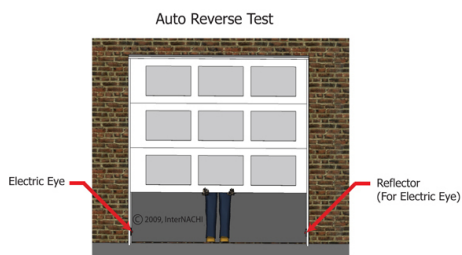
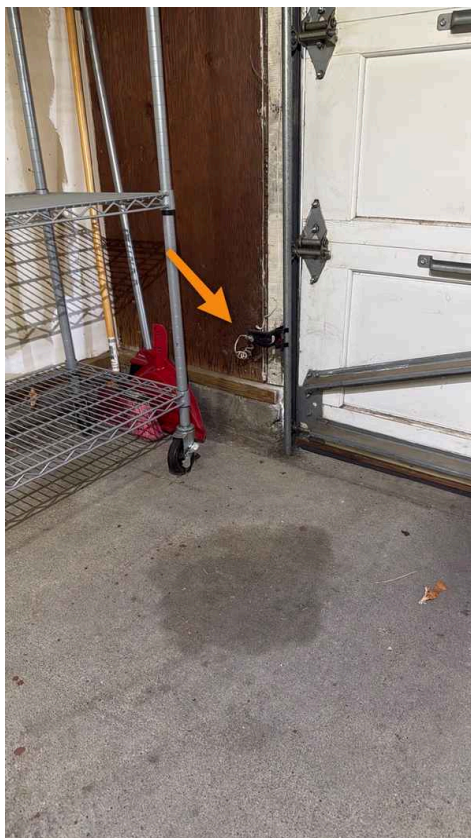
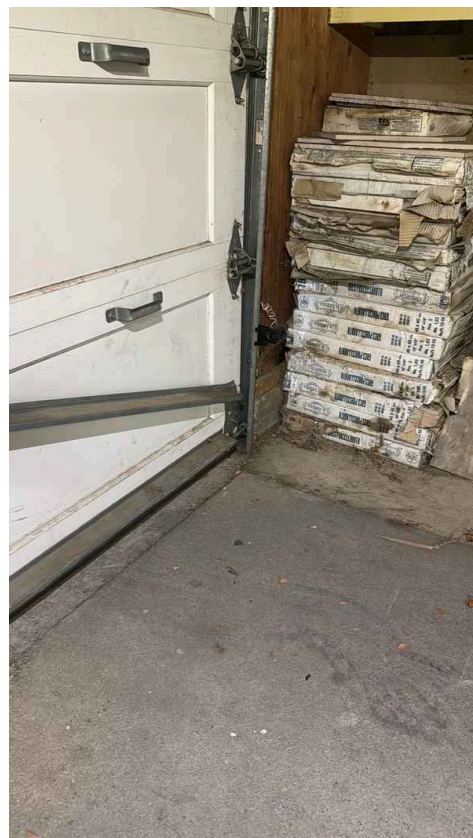
#### 4.4.1 Garage Door

### PHOTO EYE SENSOR MODIFICATIONS

Photo eye sensors are placed too high, we recommend no greater than 6" from the ground.

Contact a qualified garage door contractor.

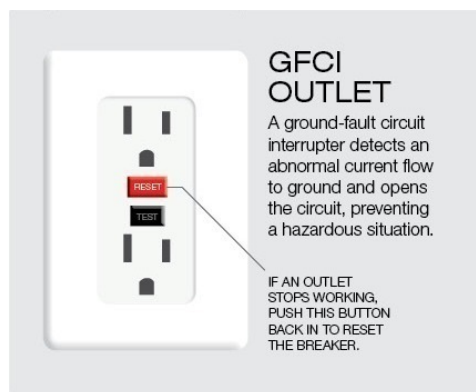
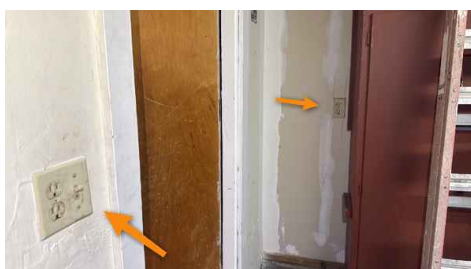
### 4.5.1 Lighting Fixtures, Switches & Receptacles

#### GFCI MISSING

No GFCI protection was present in some locations. GFCIs are recommended in kitchens, baths, garages, and exterior applications. I recommend a licensed electrician upgrade by installing ground fault receptacles in all necessary locations.

Contact a qualified electrical contractor.

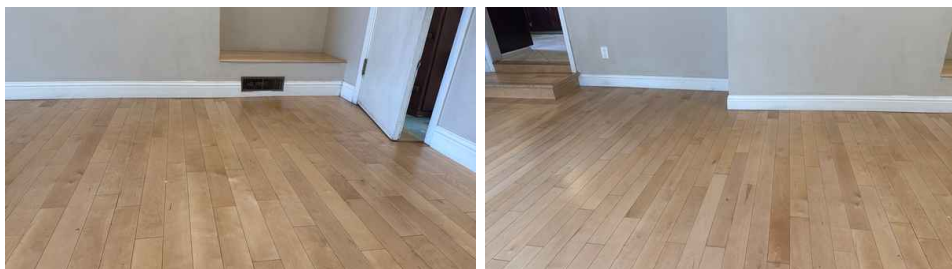
VARIOUS LOCATIONS

### 5.2.1 Floors

#### UNEVENNESS

**Observation:** The floor showed uneven or sloped surfaces in some areas, which may be due to improper installation or previous settlement, a common issue in older structures.

**Recommendation:** I recommend having a qualified contractor investigate the floor structure, evaluate the cause of the unevenness, and repair it as needed to ensure the floor's stability and safety.

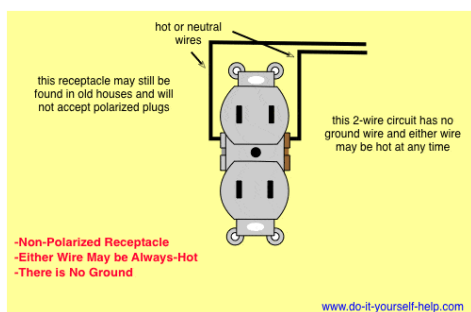
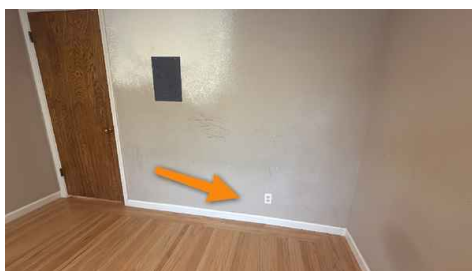
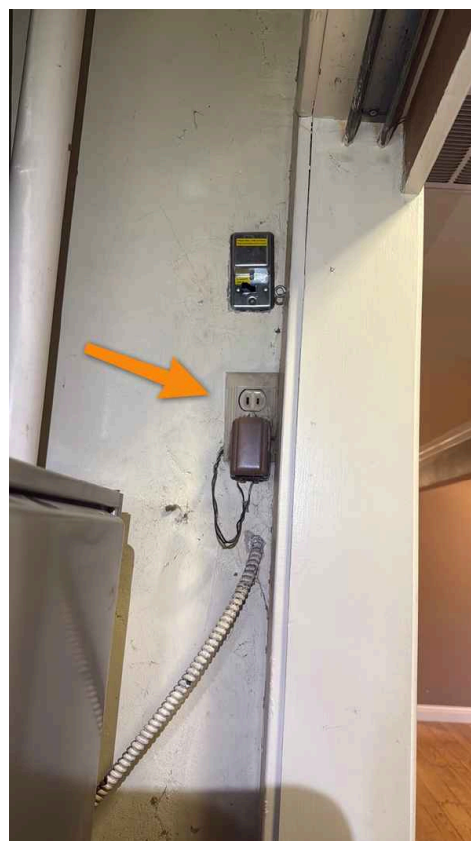
### 5.4.3 Lighting, Fans, Switches, & Receptacles

#### UNGROUNDED RECEPTACLE

Some receptacles were ungrounded. To eliminate safety hazards, all receptacles in kitchens, bathrooms, garages & the exterior should be grounded. **At the minimum, a GFCI should be installed for additional safety. It may be possible with a panel upgrade to install GFCI rated breakers.**

Parts of the electrical system is two wire which explains the ungrounded receptacles.

Contact a qualified electrical contractor.

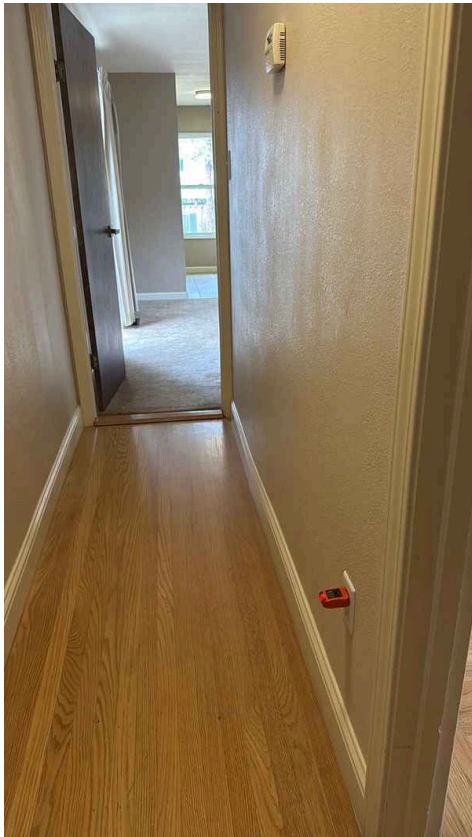
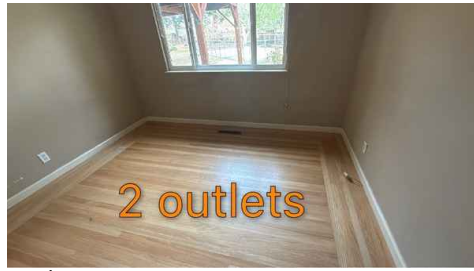
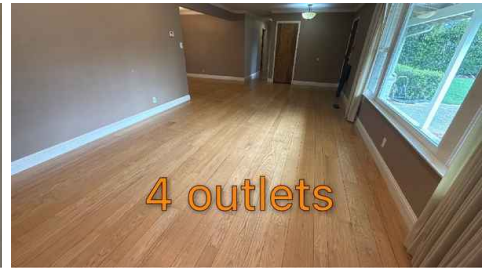
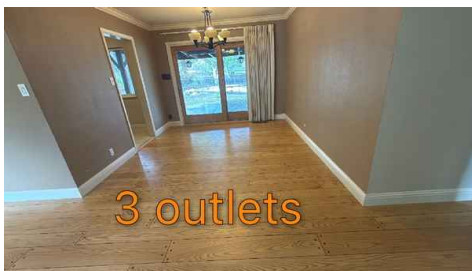
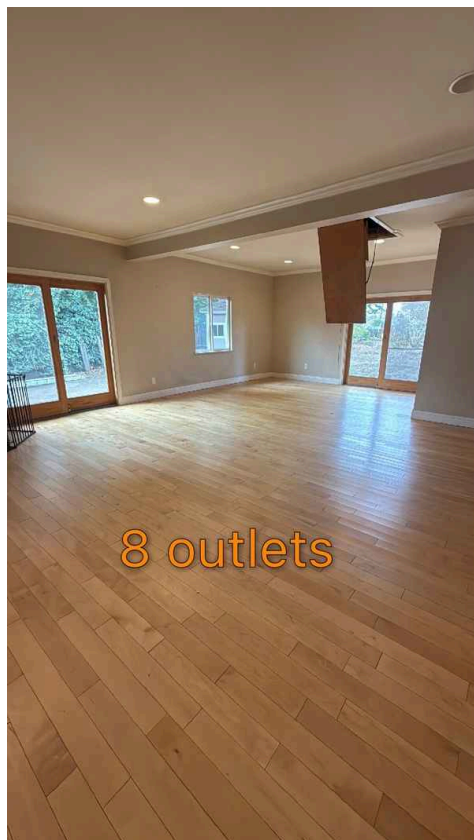
### 5.4.4 Lighting, Fans, Switches, & Receptacles

#### OPEN GROUND

Open ground electrical issue discovered during inspection. Recommend electrician evaluation.

Contact a qualified electrical contractor.

It's recommended once panel is upgraded that AFCI/GFCI circuit breakers are installed to remedy the open ground situation with various receptacles throughout the property.

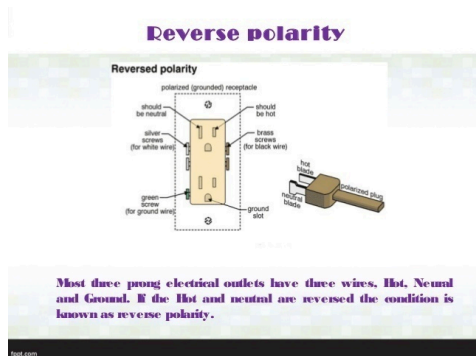
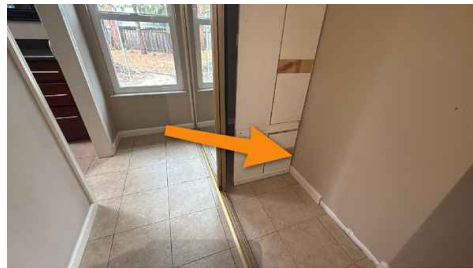
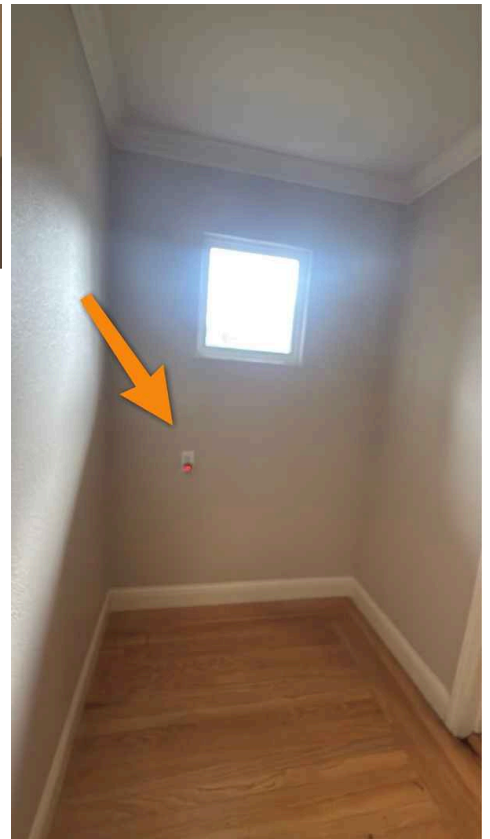
5.4.5 Lighting, Fans, Switches, & Receptacles

**REVERSE POLARITY**

Some receptacles had been wired with reverse polarity. This can cause damage to electronics or computers. I recommend a licensed electrician evaluate & repair.

Contact a qualified electrical contractor.

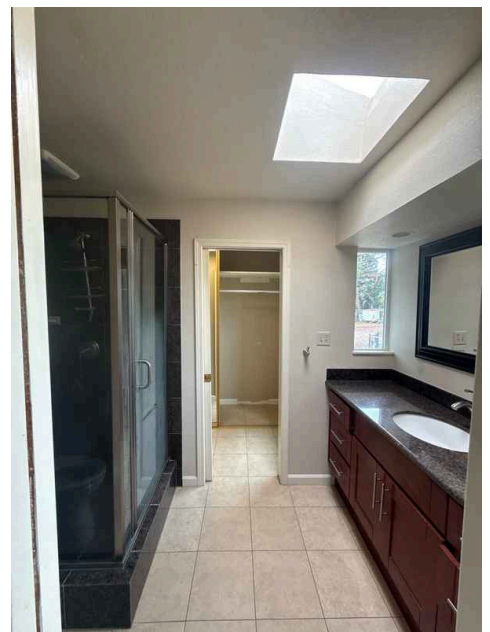
6.1.1 Doors & Windows

**NOT SQUARE**

Door isn't square likely due to settling that is occurring on the right side of the home.

Contact a qualified professional.

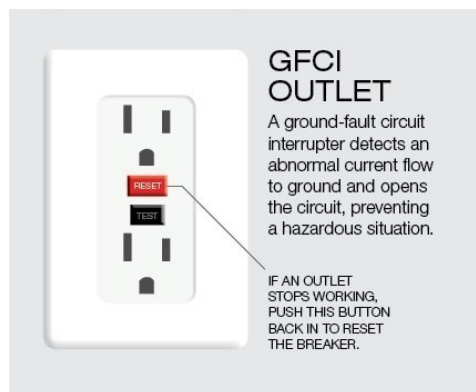
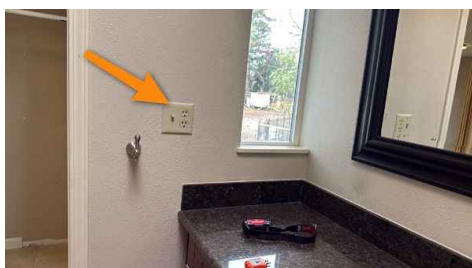
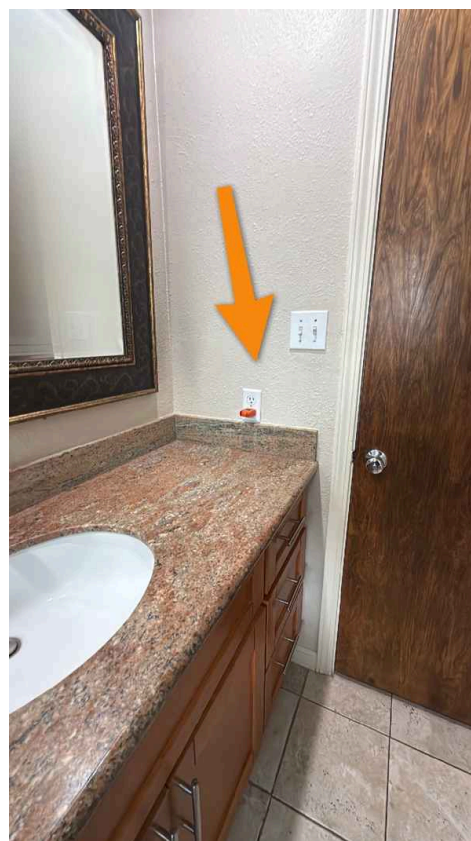
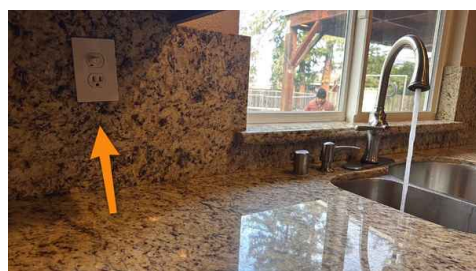
6.5.1 Lighting, Fans, Switches, & Receptacles

**GFCI MISSING**

GFCI protection was not present in some locations. GFCIs are recommended in kitchens, baths, garages, and exterior applications. I recommend a licensed electrician upgrade by installing ground fault receptacles in all necessary locations.

**Its easier to replace circuit breaker feeding outlets with a GFCI rated circuit breaker to provide protection.**

Contact a qualified electrical contractor.

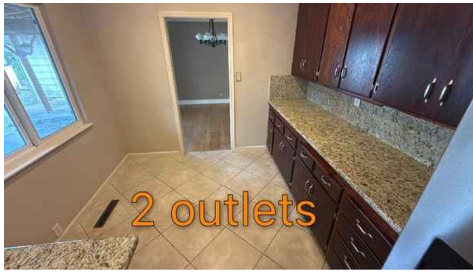
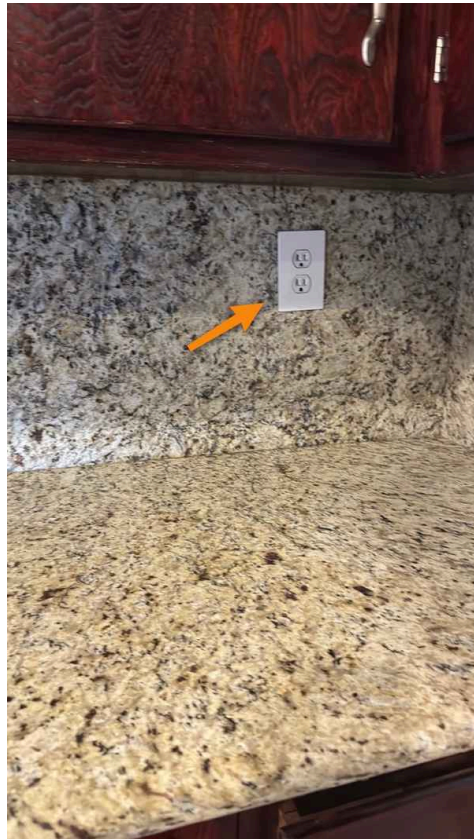
6.5.2 Lighting, Fans, Switches, & Receptacles

**OPEN GROUND**

Open ground electrical issue discovered during inspection. This indicates a potential safety risk for electrical receptacles.

Contact a qualified professional.

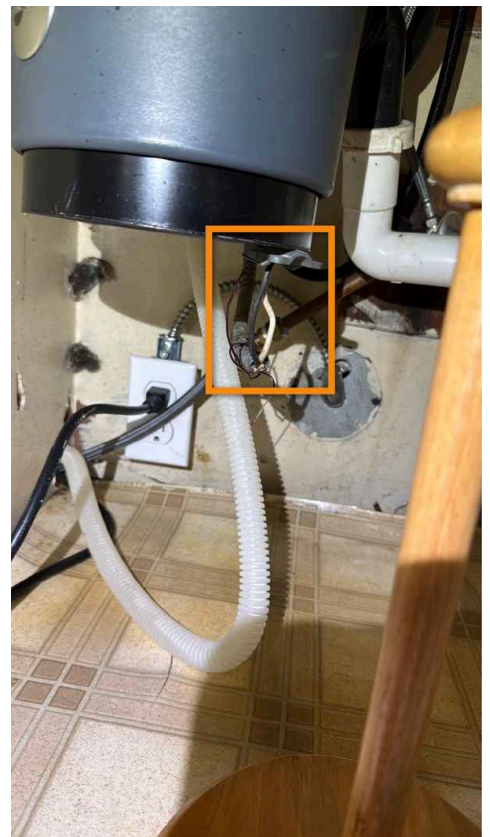
6.5.3 Lighting, Fans, Switches, & Receptacles

**UNPROFESSIONAL**

It's recommended that cable is properly terminated into garbage disposal component.

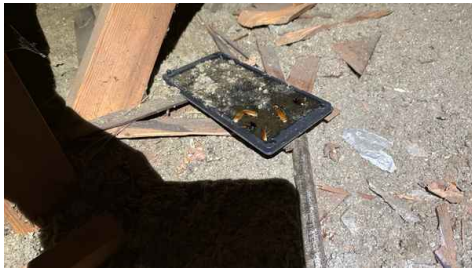
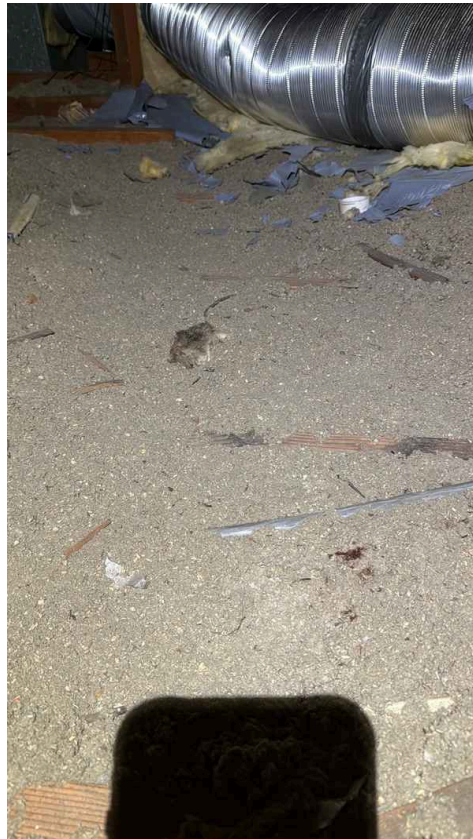
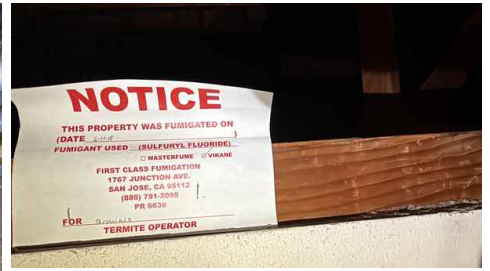
8.3.1 Roof & Attic Structure  
**PEST ACTIVITY**

Evidence of pest activity was noted in the attic portion. **No pest were found during the inspection.**

Contact a qualified pest control specialist.

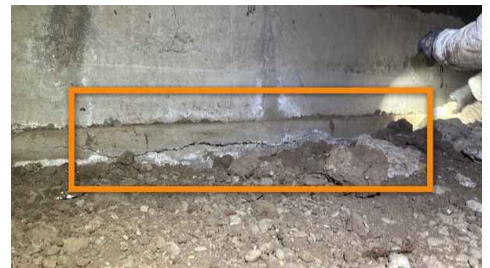
9.2.2 Foundation Walls  
**MODERATE CRACK**

Moderate cracks were observed in the foundation wall, which is a significant concern as it may indicate structural issues, potential shifting, or water intrusion.

For a home to have some minor cracks in the foundation is pretty common due to settling.

**Recommendation:** evaluation by a foundation specialist is strongly advised to assess the severity and determine necessary repairs (such as epoxy injection, underpinning, or wall stabilization)

Contact a foundation contractor.

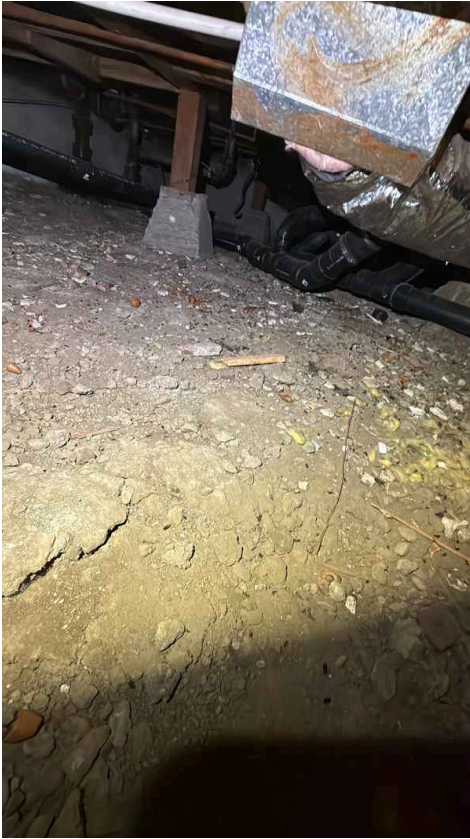
9.3.1 Beams, Columns, & Joists  
**PEST ACTIVITY (RODENT)**

Vermin or pest activity was noted. I recommend consulting a pest technician for further review and mitigation if needed.

Contact a qualified pest control specialist.

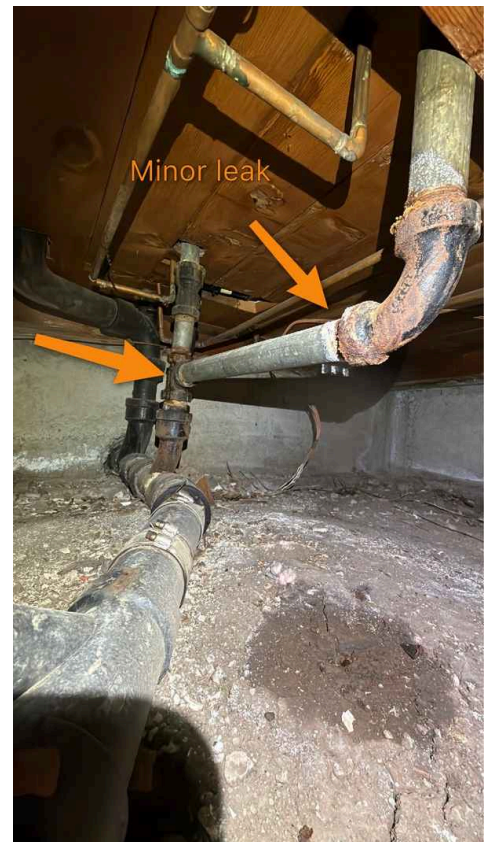
Front Crawlspace

### 10.2.1 Drain, Waste, & Vent Systems **COMPONENT LEAK**

**Observation:** A drain pipe or component showed signs of a leak.

**Recommendation:** It is recommended to have a qualified plumber evaluate and repair the leak soon, before use, to prevent further damage and ensure the system operates properly.

Recommendation  
Contact a qualified plumbing contractor.

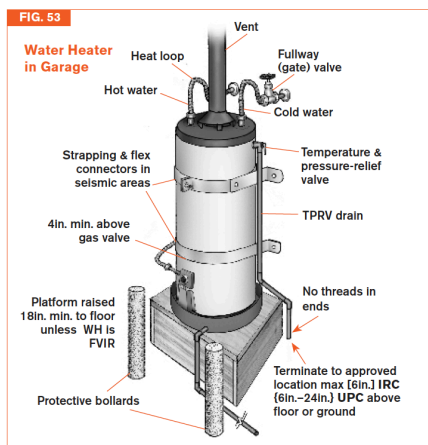
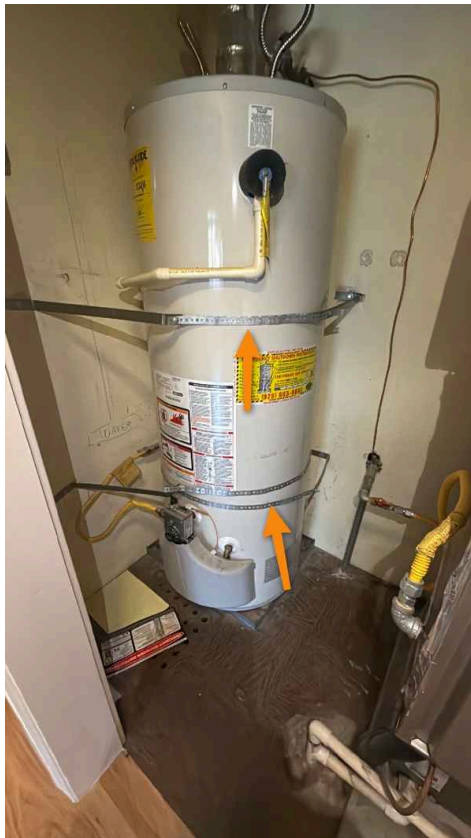
10.3.1 Water Heater(s)

**IMPROPER SEISMEC STRAPPING**

Improper seismic strapping increases the risk of equipment tipping over during an earthquake, leading to property damage, gas or water leaks, personal injury, and code violations. It can also result in failed inspections and denied insurance claims. To ensure safety, straps must be properly installed per local codes, securely anchored to studs or concrete, and tightened to prevent movement.

Contact a handyman or DIY project

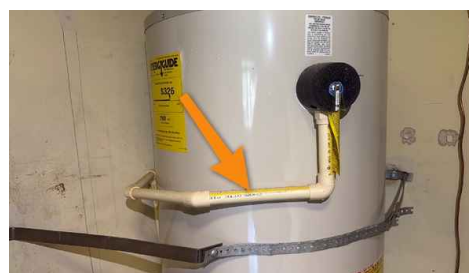
10.3.3 Water Heater(s)

**TPR PIPE**

**Improper material copper piping is recommended not pvc.**

It is recommended a temperature pressure relief valve extension pipe be installed within 4 inches of the ground surface.

Contact a qualified HVAC professional.

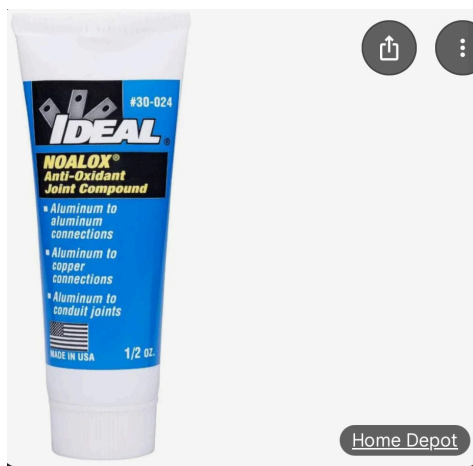
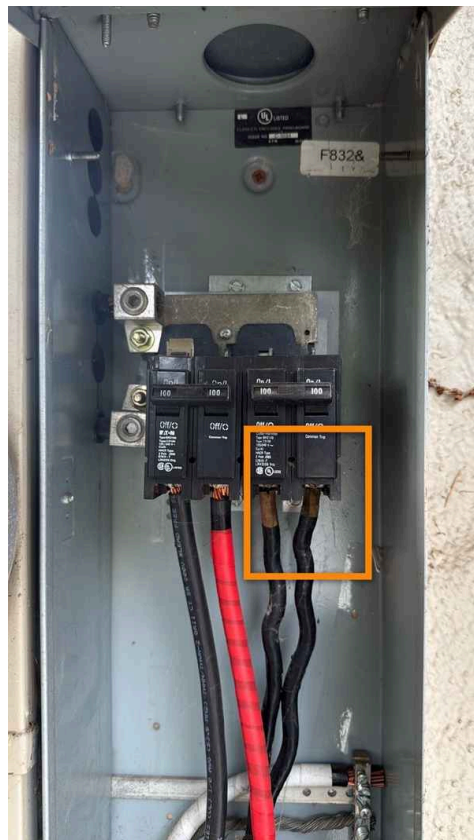
Service panel

12.2.1 Service/Main Disconnect and Subpanels

**ANTIOXIDANT PASTE**

The aluminum conductors observed in the electrical panel lack antioxidant paste, which is essential to prevent oxidation and ensure proper conductivity. It is recommended to apply an approved antioxidant compound to the connections to reduce the risk of overheating and improve electrical safety. A qualified electrician should address this issue.

Contact a qualified electrical contractor.

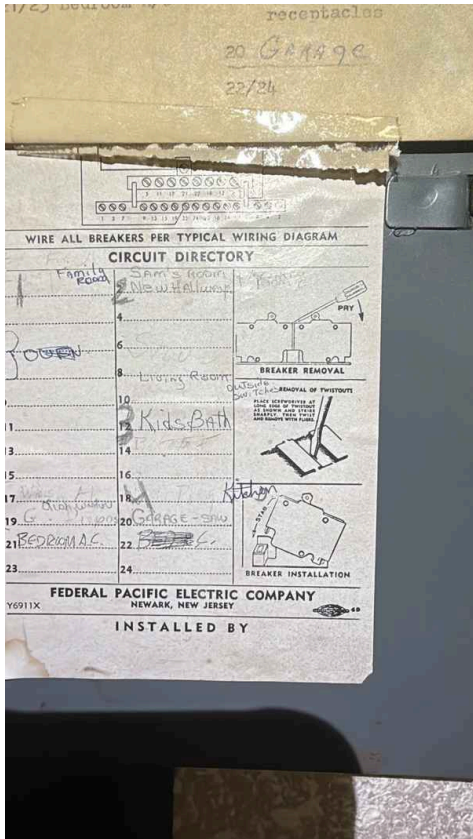
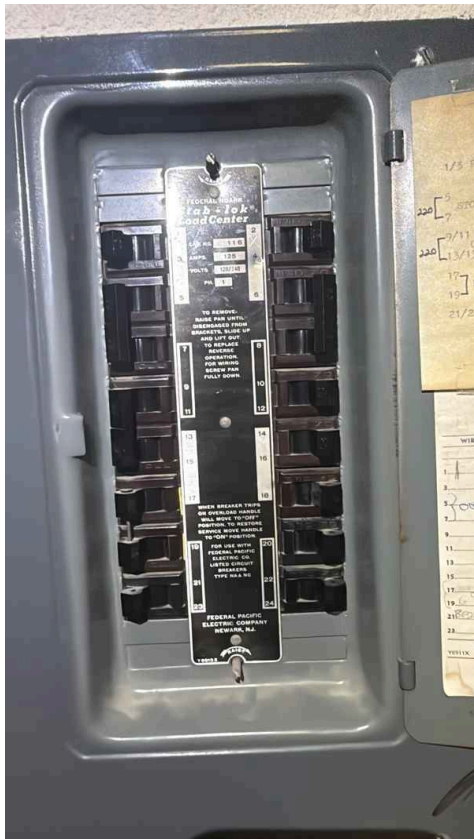
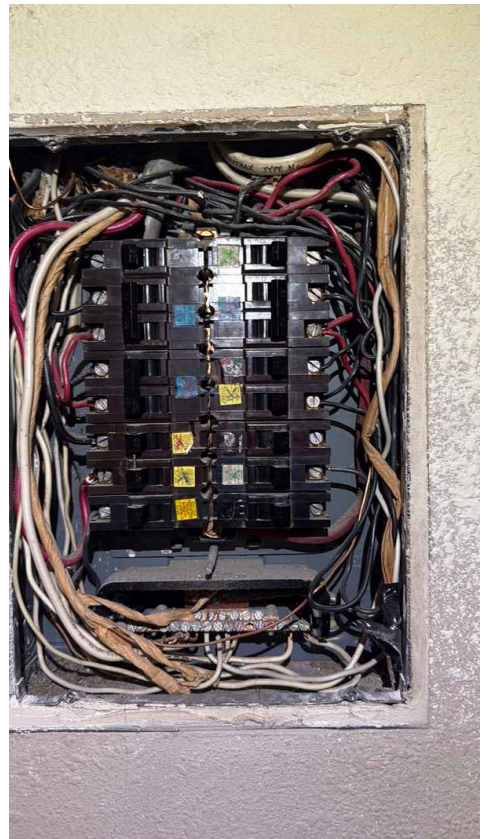
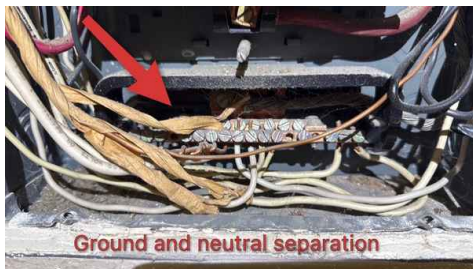
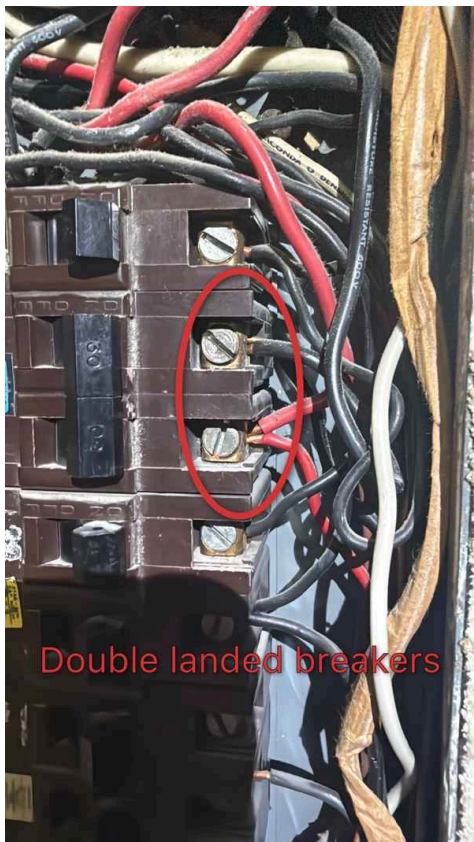
#### 12.2.3 Service/Main Disconnect and Subpanels

##### FEDERAL PACIFIC

**Observation:** The electrical panel is a Federal Pacific brand, which is known for potential safety concerns, including defective breakers that may not trip during an overload or short circuit.

**Recommendation:** I recommend having a licensed electrician evaluate the panel and consider replacing it with a more reliable, code-compliant system to ensure safety.

Recommendation  
Contact a qualified electrical contractor.
