# FOREST PROPERTY INSPECTIONS

## PROPERTY INSPECTION

132 Cafeto Ct  
Walnut Creek, CA 94598

02/18/2026

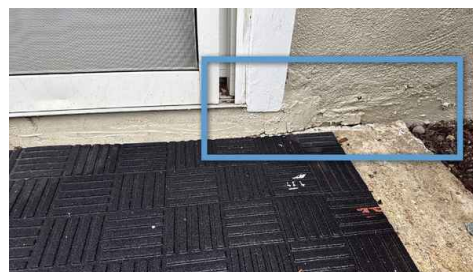
Left

2.1.3 Wall Covering

Recommendation

Contact a qualified siding specialist.

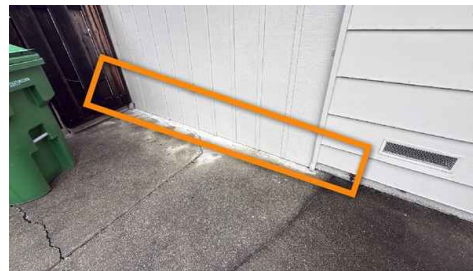
Left Garage

2.1.4 Wall Covering

Recommendation

Contact a qualified siding specialist.

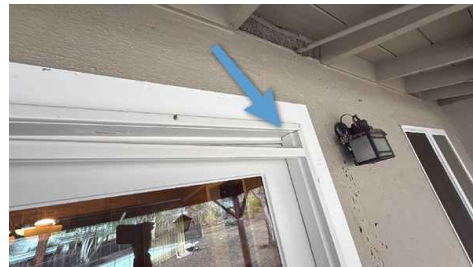
Living Room Rear

2.2.1 Doors and Windows

Deferred Maintenance / Modifications

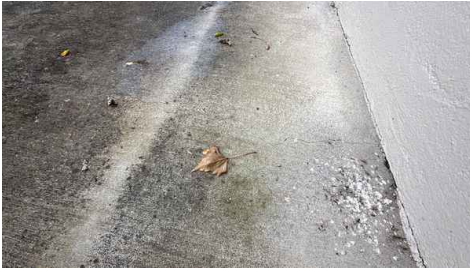
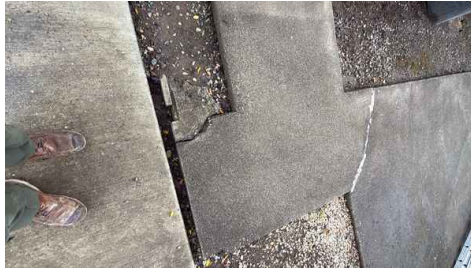
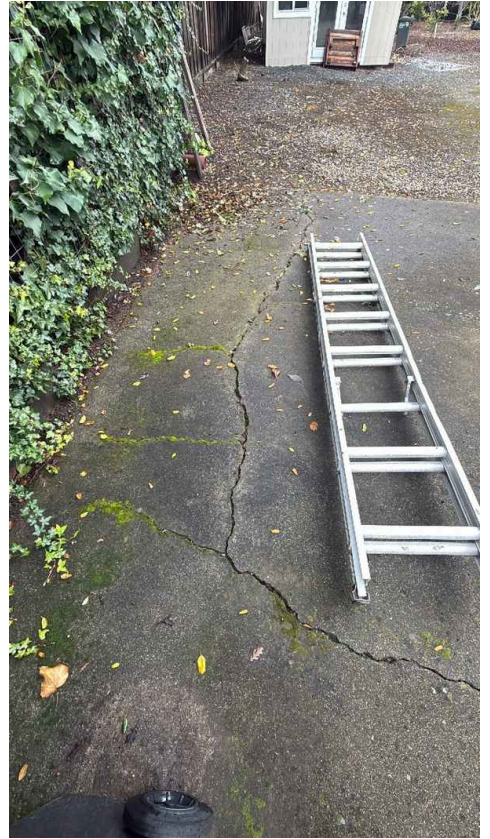
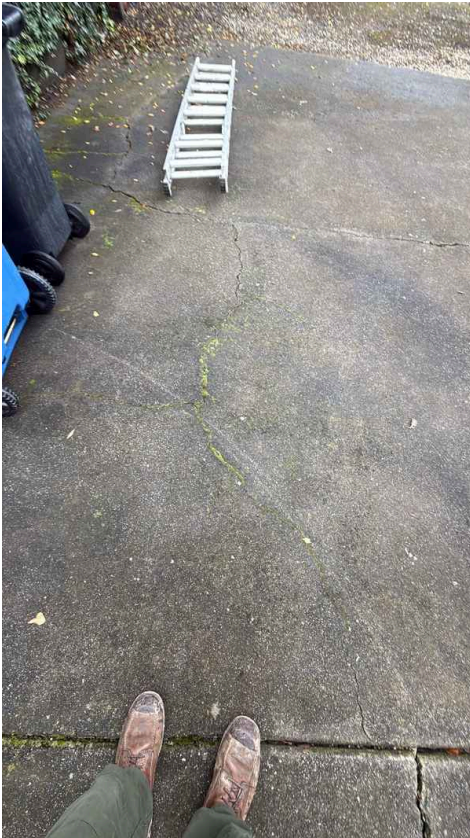
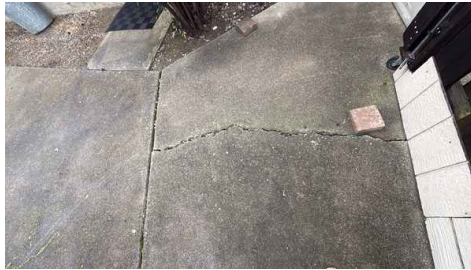
2.3.1 Walkways, Patios & Driveways

Deferred Maintenance / Modifications

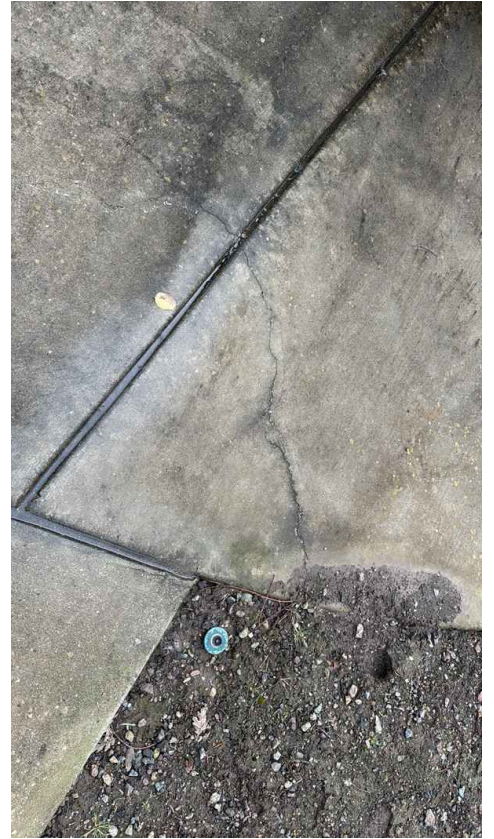
Some settling and cracking was observed on the patio, which may affect its appearance and structural integrity. I recommend repairing or patching the cracks and sealing the patio to prevent further damage and extend its lifespan.

#### Recommendation

Contact a qualified concrete contractor.

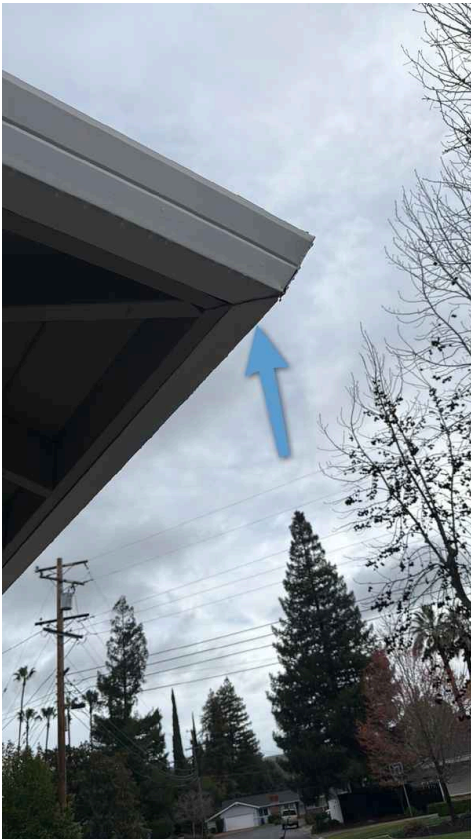
Front Left

### 2.5.1 Roof Drainage Systems

Deferred Maintenance / Modifications

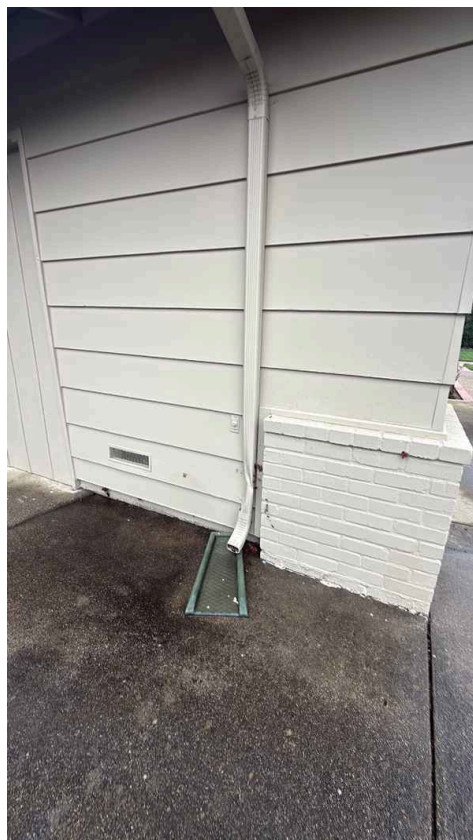
Left

Moisture Intrusion - Downspout

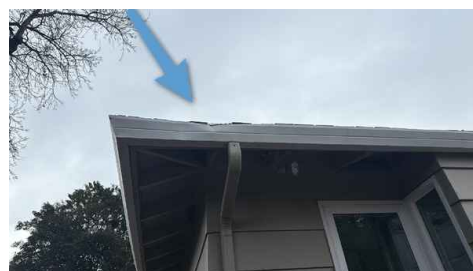
Rear Right

### 2.5.2 Roof Drainage Systems

Recommendation

Contact a qualified gutter contractor

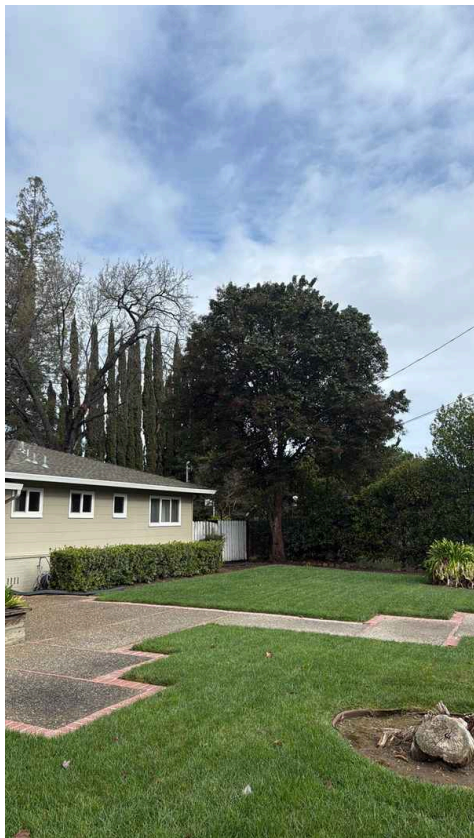
2.6.1 Vegetation, Grading, Drainage, & Retaining Walls

Recommendation

Contact a qualified tree service company.

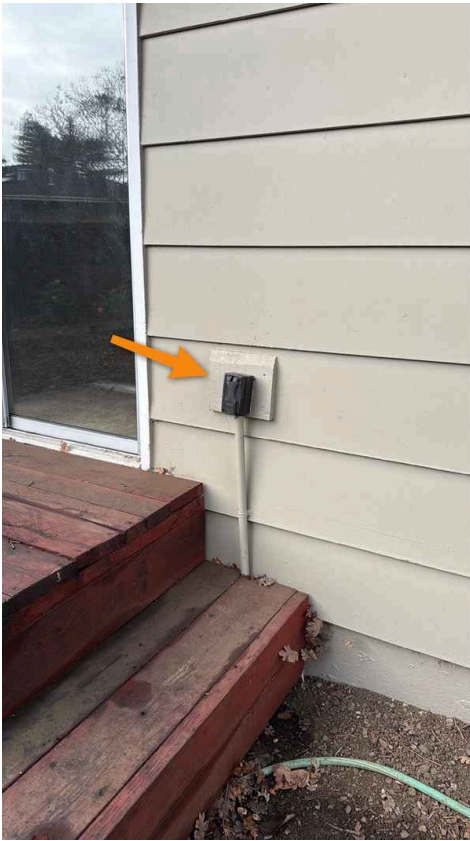
Right

### 2.9.1 Exterior Lighting Fixtures, Fans, Switches, & Receptacles

Recommendation

Contact a qualified electrical contractor.

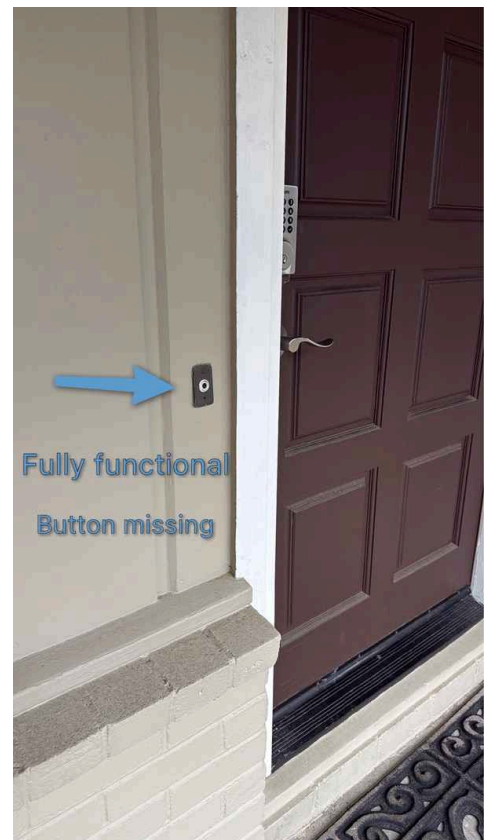
2.9.2 Exterior Lighting  
Fixtures, Fans, Switches, &  
Receptacles

Recommendation

Contact a qualified electrical contractor.

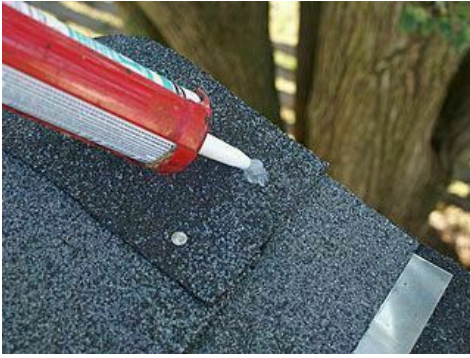
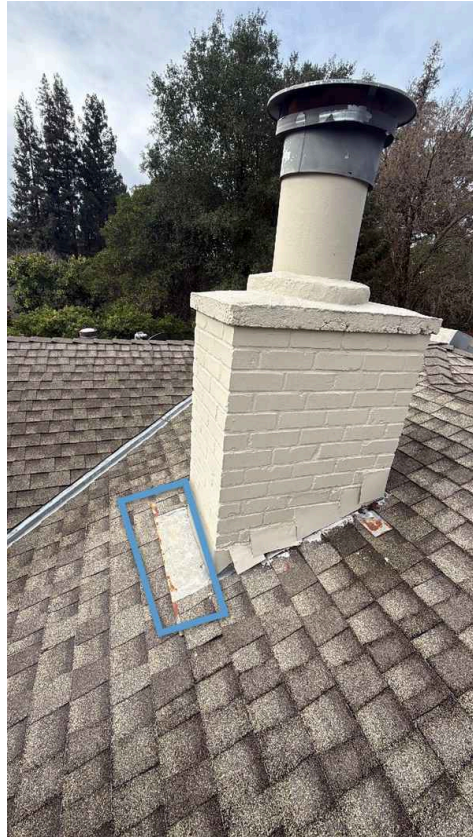
Roof nails were exposed, which are great entry points for water when it rains. It's recommended that these are sealed with a caulk.

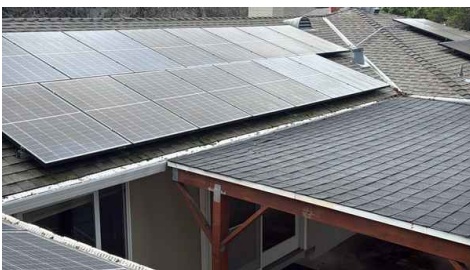
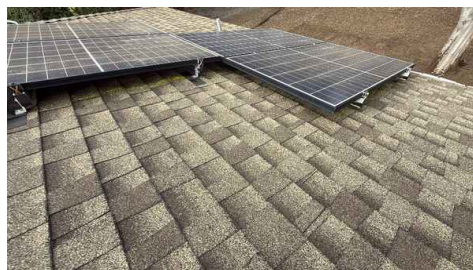
3.1.2 Coverings

**MOSS / STAINING**

Moss growth and staining on roof coverings indicates moisture retention and potential degradation. This can compromise roof integrity and lead to premature material breakdown.

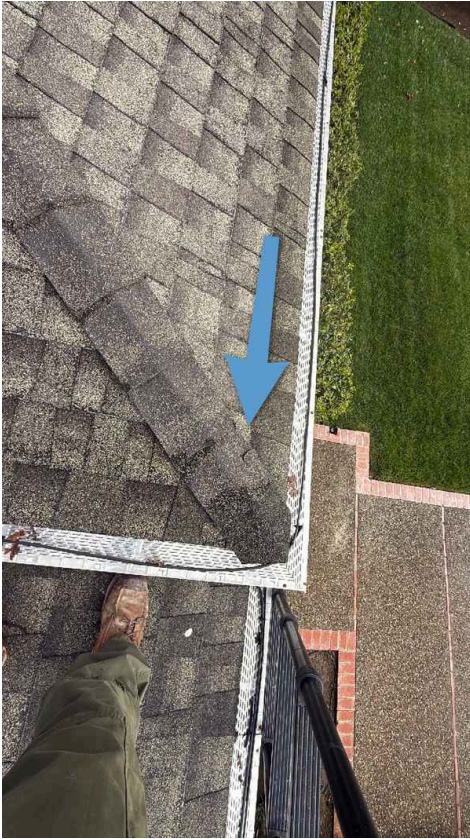
3.1.3 Coverings

**LOCALIZED DAMAGE**

Roof covering shows targeted damage area requiring professional assessment. Potential compromise of waterproofing and structural integrity exists.

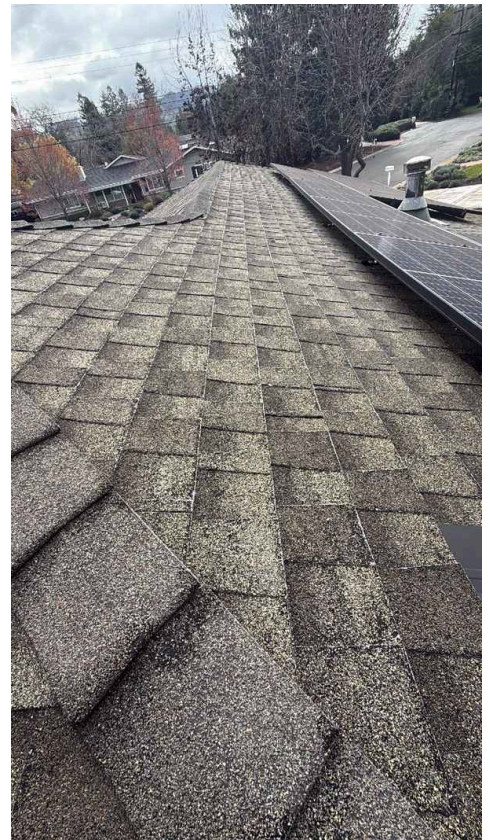
**DELAMINATION  
OBSERVED**

Delamination indicates material separation or breakdown in roof coverings. This creates potential water penetration risks and structural vulnerability.

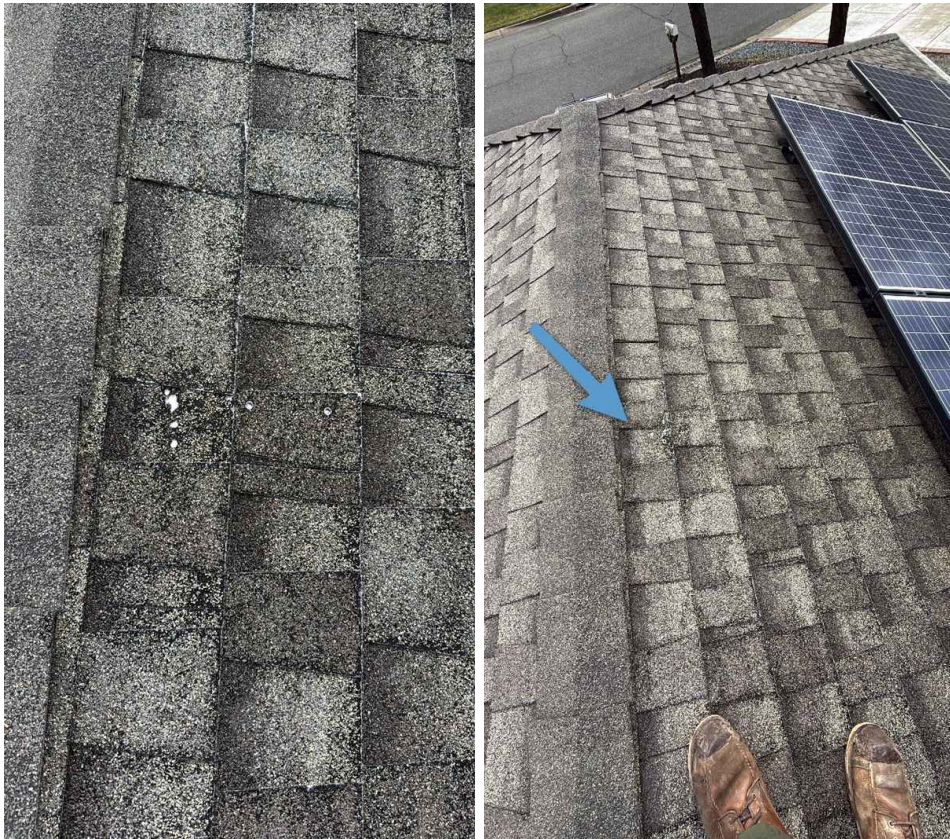
**PREVIOUS REPAIRS  
ROOF**

Previous roof repair marks indicate maintenance history. This suggests past issues addressed.

Contact a qualified roofing professional.

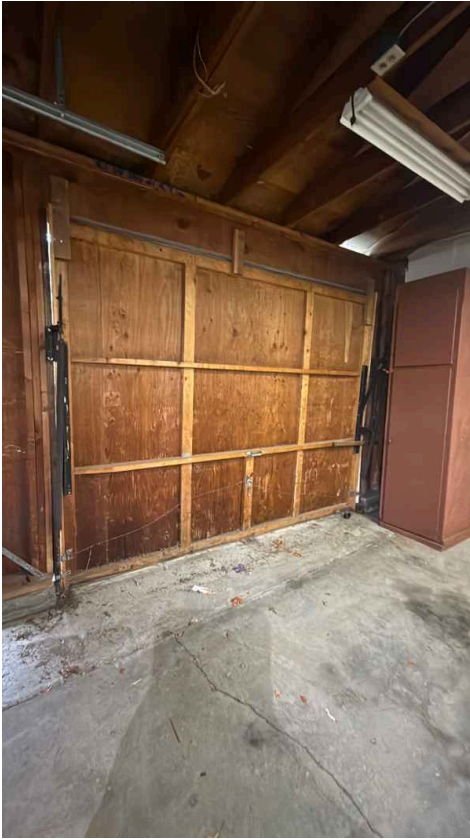
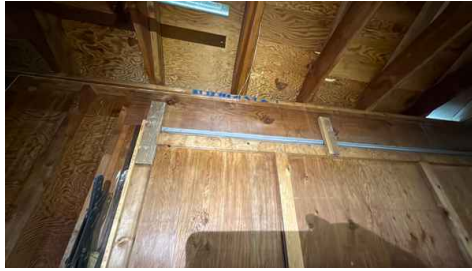
### **LOCKED**

The door was locked which prevented a full inspection.

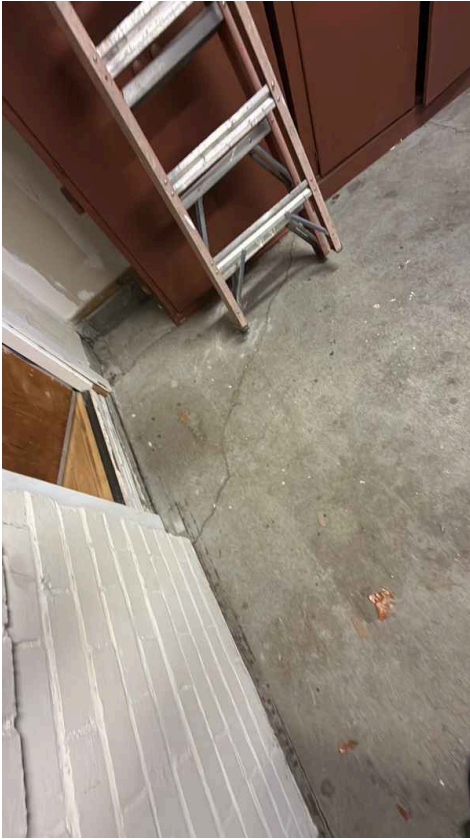
**Observation:** Minor settling cracks were observed in the garage concrete slab. These are typical in older and newer homes and do not currently appear to affect structural integrity.

**Recommendation:** No immediate action is necessary. Recommend monitoring for changes over time. If cracks widen or displacement occurs, further evaluation by a qualified contractor may be warranted.

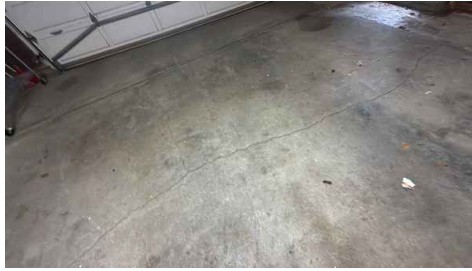
### 4.3.1 Interior Structure

#### **FLOOR CRACKING MINOR**

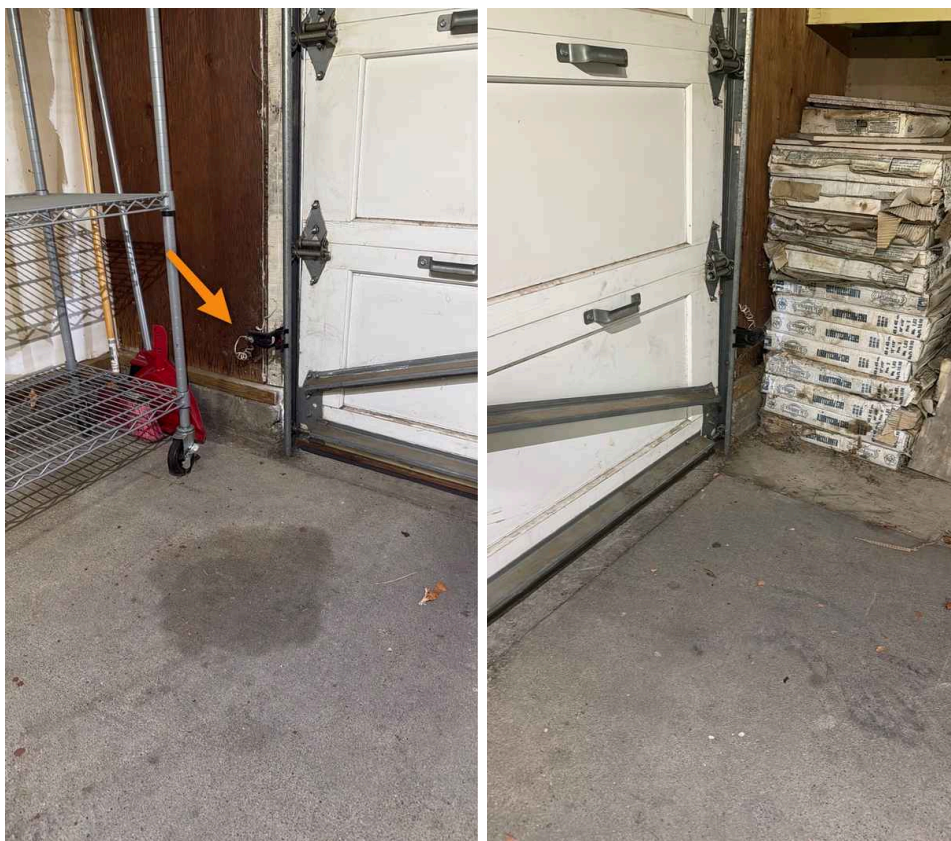
Photo eye sensors are placed too high, we recommend no greater than 6" from the ground.

Contact a qualified garage door contractor.

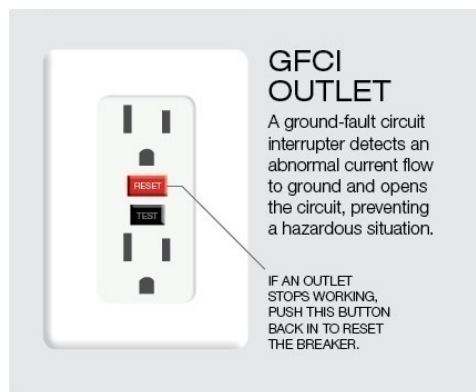
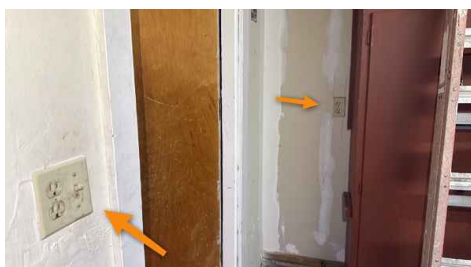
#### 4.5.1 Lighting Fixtures, Switches & Receptacles

### GFCI MISSING

No GFCI protection was present in some locations. GFCIs are recommended in kitchens, baths, garages, and exterior applications. I recommend a licensed electrician upgrade by installing ground fault receptacles in all necessary locations.

Contact a qualified electrical contractor.

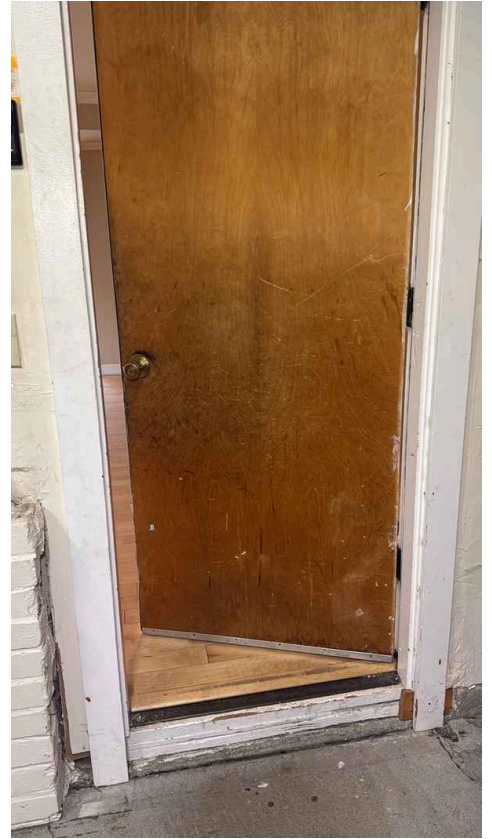
**Observation:** The interior door between the garage and the home does not fully latch on its own. This may be due to misalignment, a worn-out latch mechanism, or improper installation.

**Recommendation:** Adjust the door strike plate, hinges, or latch to ensure proper alignment and secure closure. If the issue persists, consider replacing the latch mechanism. Ensuring a proper seal is important for fire safety and to prevent fumes from the garage from entering the living space.

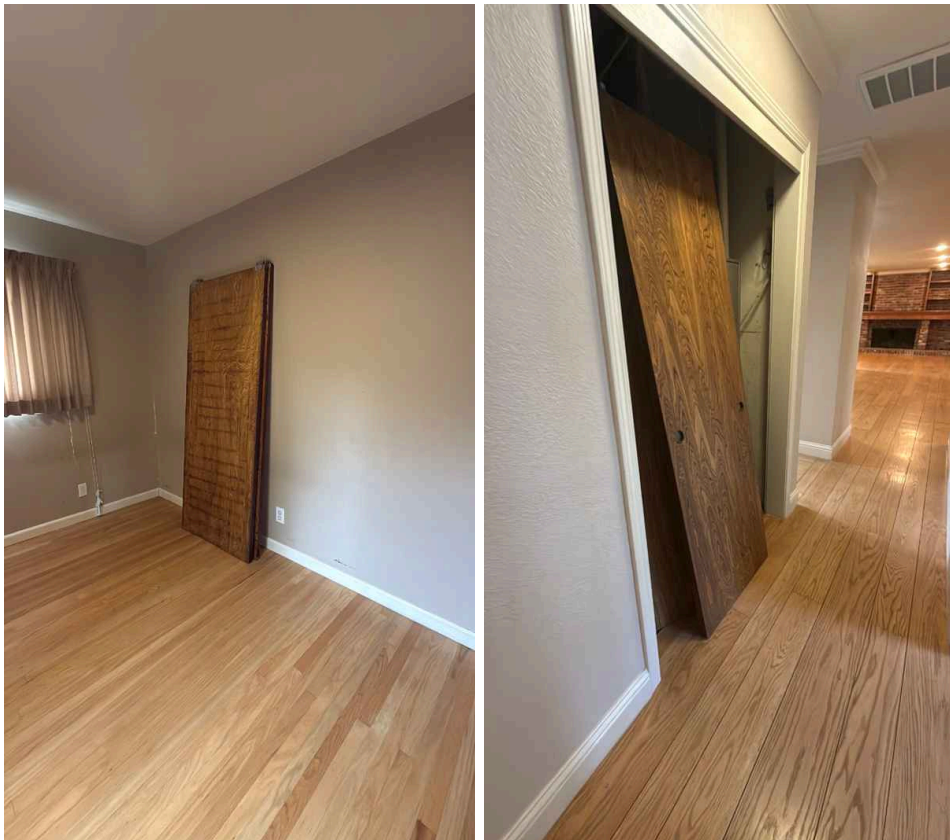
**Observation:** Closet door is off its track and not operating as intended.

**Recommendation:** Recommend adjusting or reattaching the closet door to its track for proper operation.

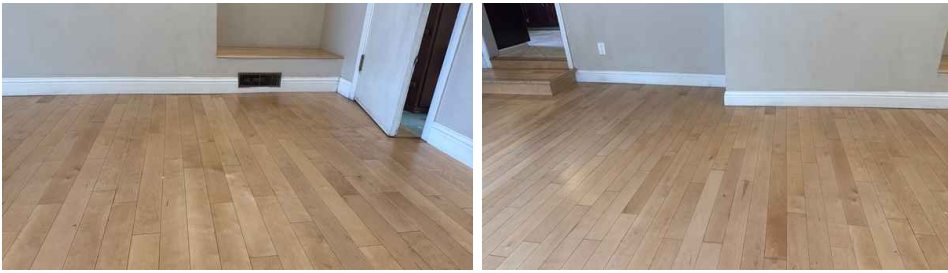
**Observation:** The floor showed uneven or sloped surfaces in some areas, which may be due to improper installation or previous settlement, a common issue in older structures.

**Recommendation:** I recommend having a qualified contractor investigate the floor structure, evaluate the cause of the unevenness, and repair it as needed to ensure the floor's stability and safety.

Contact a qualified professional.

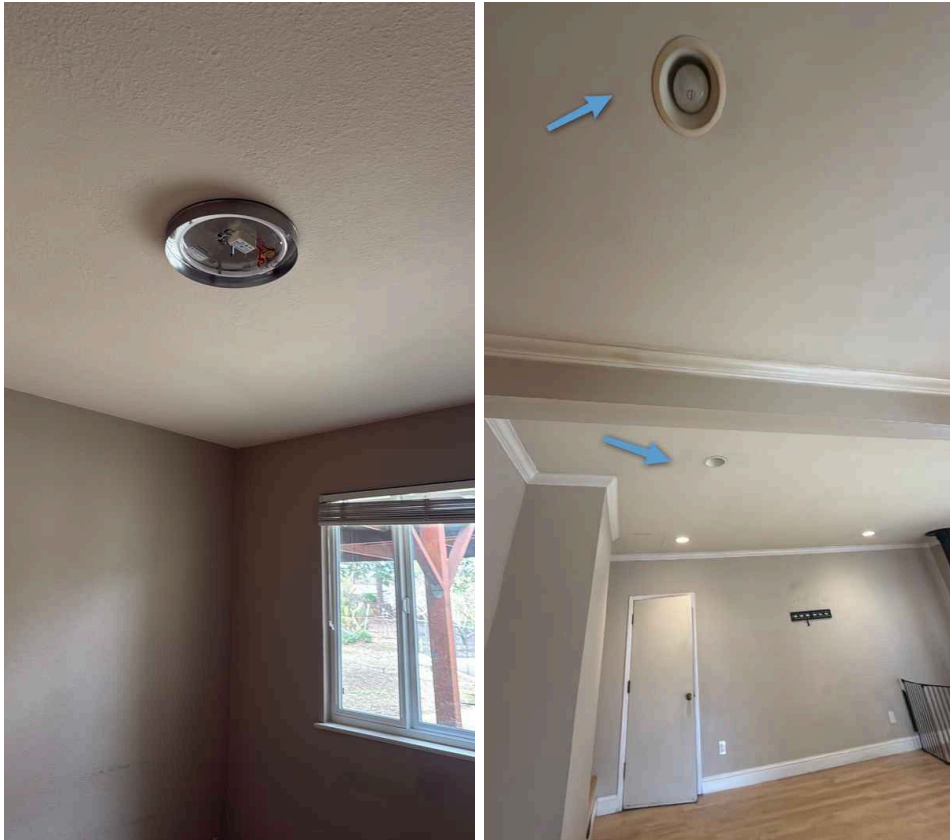
Bedroom

**Observation:** Some lights were not operating, which could be due to a burnt-out bulb, faulty switch, damaged fixture, or malfunctioning ballast.

**Recommendation:** I recommend replacing the light bulb first, and if the issue persists, having a professional investigate the problem to determine if the switch, fixture, or ballast needs repair or replacement.

Contact a handyman or DIY project

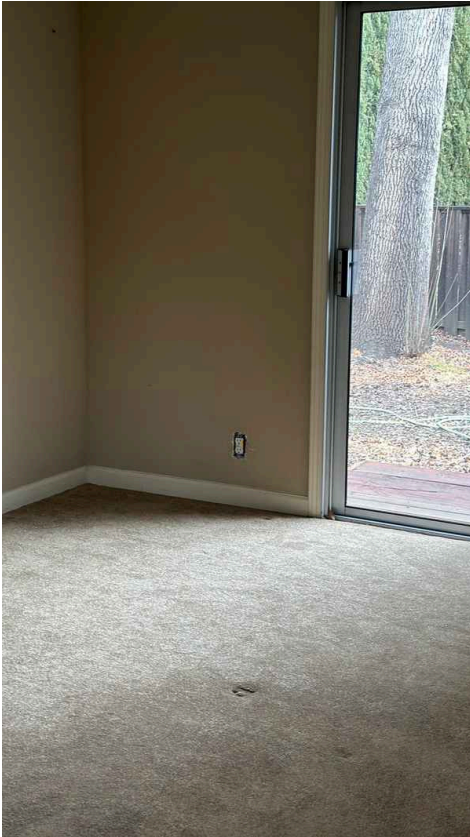
Some boxes, receptacles, or switches were missing a cover plate, or the cover plate was damaged. I recommend the installation of plates for improved safety.

Contact a handyman or DIY project

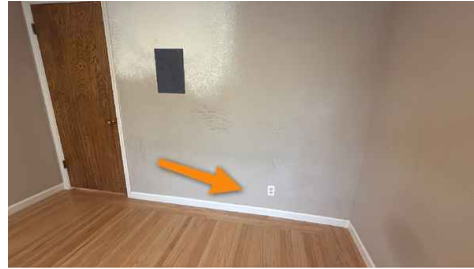
Bedroom Right

Some receptacles were ungrounded. To eliminate safety hazards, all receptacles in kitchens, bathrooms, garages & the exterior should be grounded. **At the minimum, a GFCI should be installed for additional safety. It may be possible with a panel upgrade to install GFCI rated breakers.**

Contact a qualified electrical contractor.

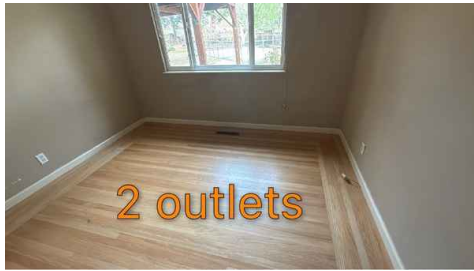
Bedroom

Open ground electrical issue discovered during inspection. Recommend electrician evaluation.

Contact a qualified electrical contractor.

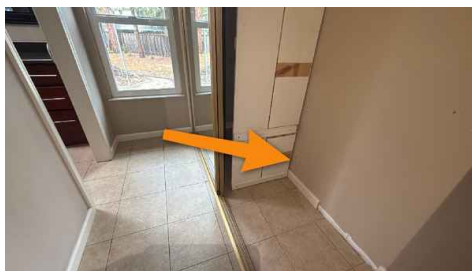
Master closet

Some receptacles had been wired with reverse polarity. This can cause damage to electronics or computers. I recommend a licensed electrician evaluate & repair.

Contact a qualified electrical contractor.

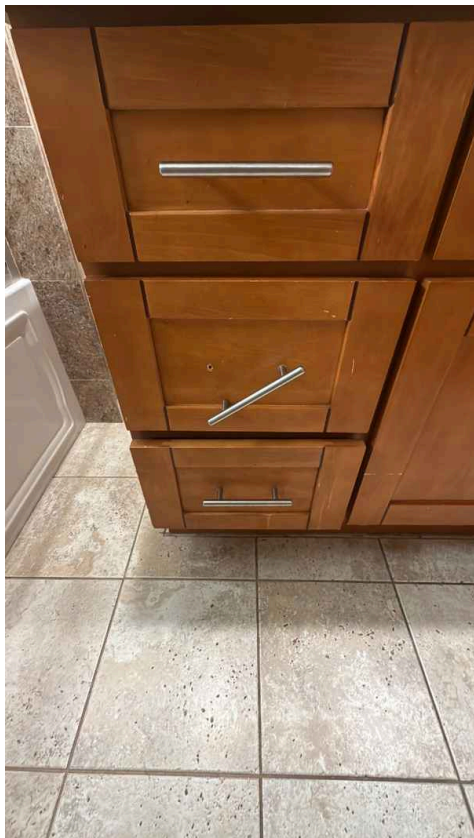
### LOOSE HANDLE

**Observation:** A loose cabinet handle was noted. This may impact functionality and could become further loosened over time.

**Recommendation:** I recommend securing or tightening the handle to ensure proper operation. If the hardware is damaged, consider replacing it.

Contact a handyman or DIY project

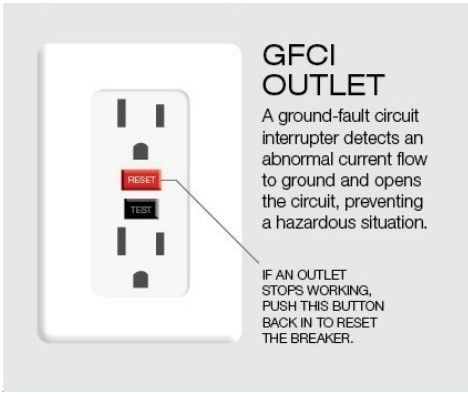
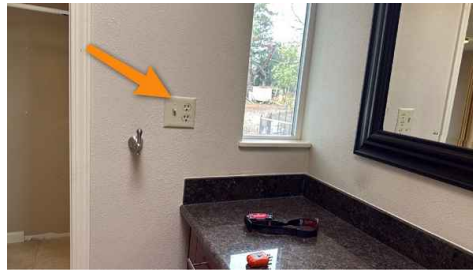
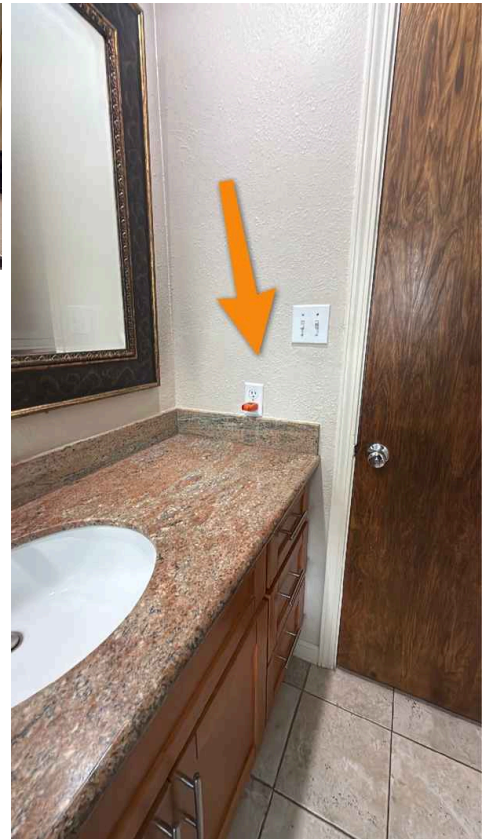
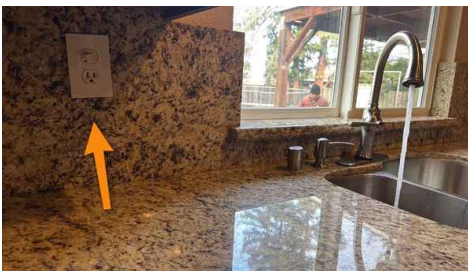
### **GFCI MISSING**

GFCI protection was not present in some locations. GFCIs are recommended in kitchens, baths, garages, and exterior applications. I recommend a licensed electrician upgrade by installing ground fault receptacles in all necessary locations.

**Its easier to replace circuit breaker feeding outlets with a GFCI rated circuit breaker to provide protection.**

Contact a qualified electrical contractor.

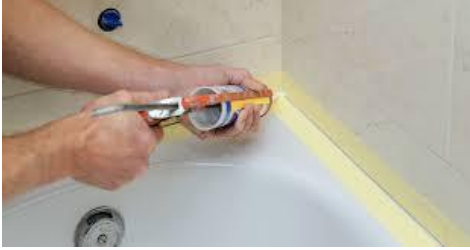
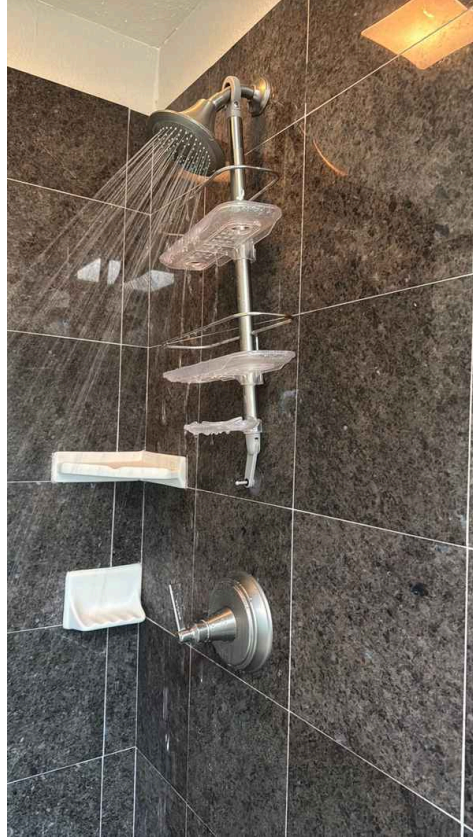
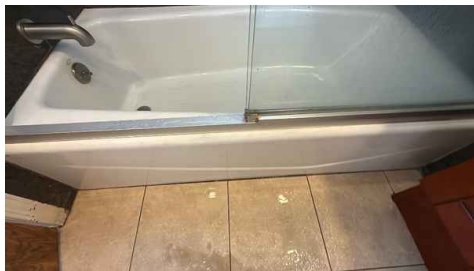
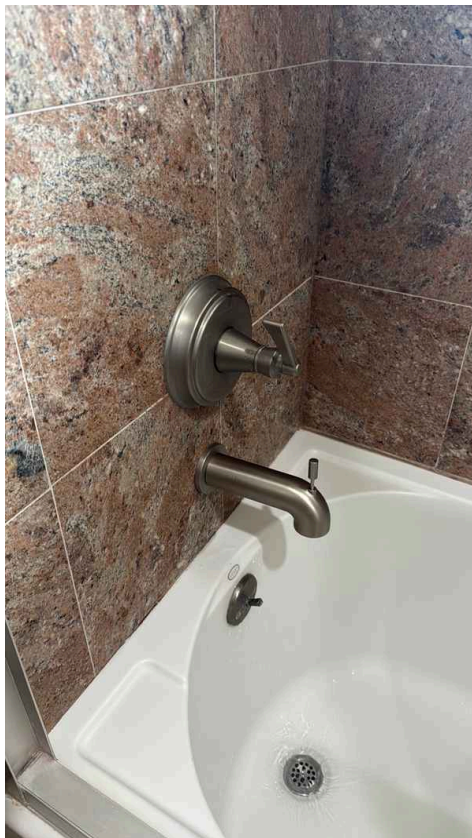
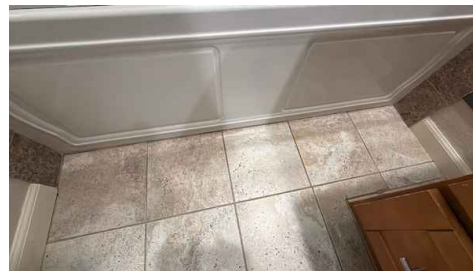
**Observation:** The caulking in this area is aged, deteriorated or missing, which may allow moisture intrusion over time.

**Recommendation:** Remove the old caulk and apply new sealant to help protect against moisture and maintain a proper seal.

Contact a handyman or DIY project

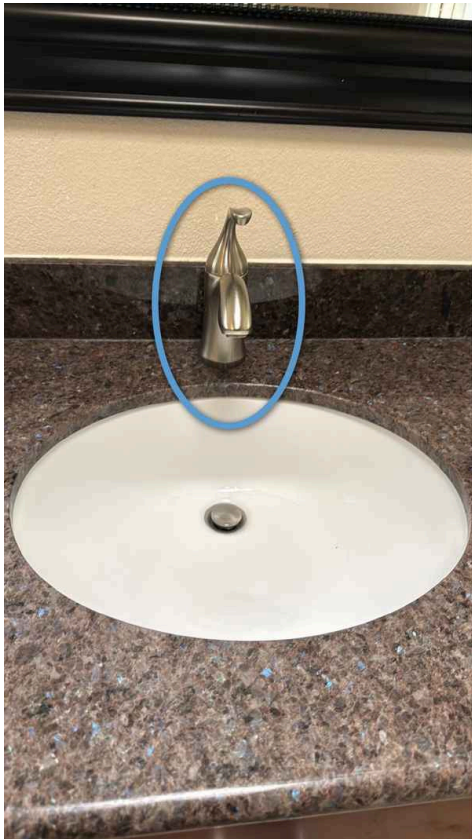
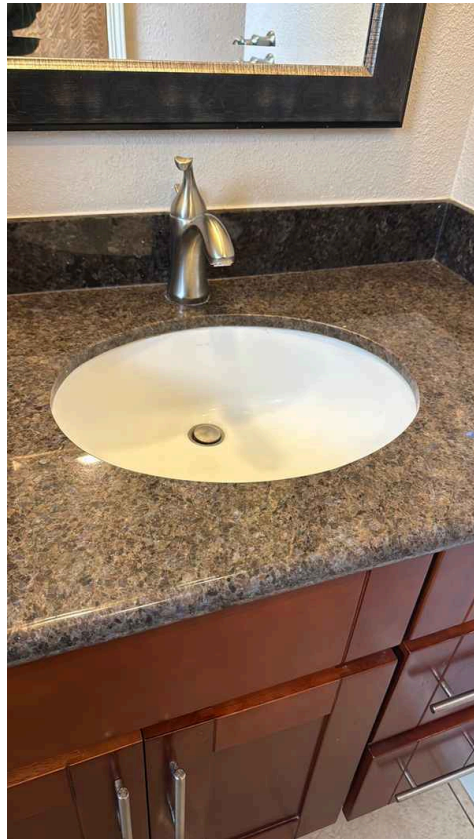
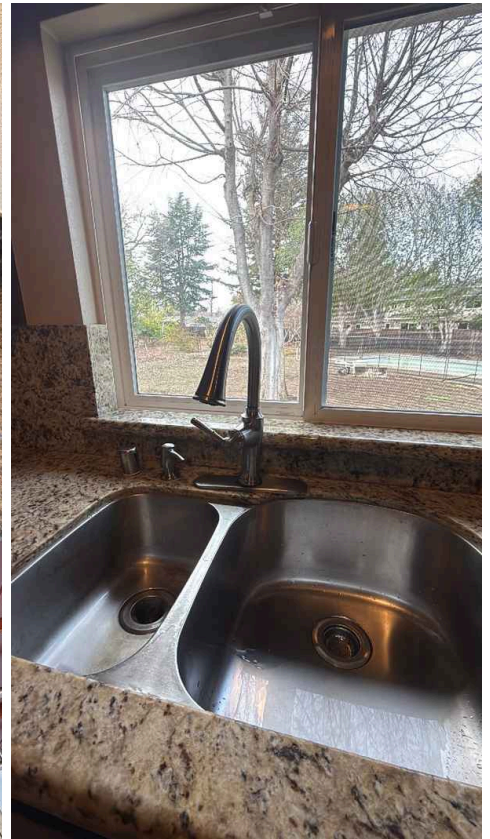
### LOOSE COMPONENTS

**Observation:** Some components were noted to be loose, which may affect the functionality or safety of the system.

**Recommendation:** I recommend that a qualified professional evaluate and secure these loose components to ensure proper function and safety.

Contact a qualified plumbing contractor.

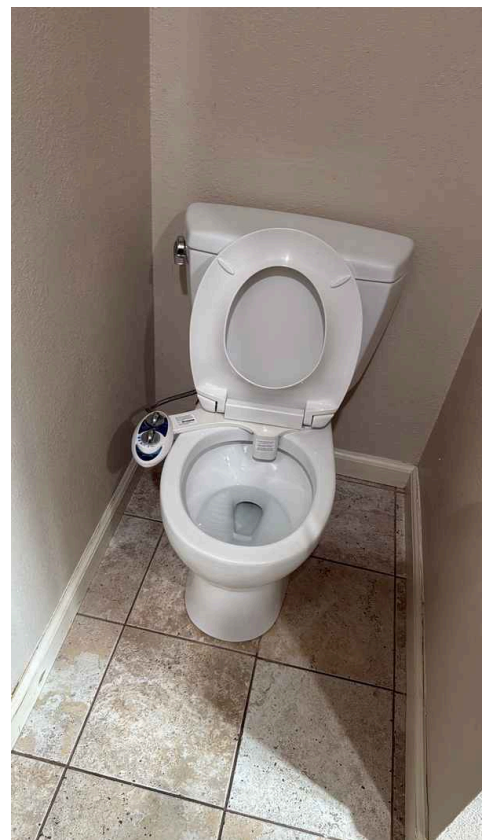
Hall Bathroom

**LOOSE TOILET**

**Observation:** The toilet was found to be loose, which can lead to instability and potential leaks.

**Recommendation:** I recommend checking the wax ring before securing the toilet to the floor. If the wax ring is damaged or deteriorated, it should be replaced to prevent leaks. Afterward, the toilet should be properly secured to the floor.

Contact a qualified plumbing contractor.

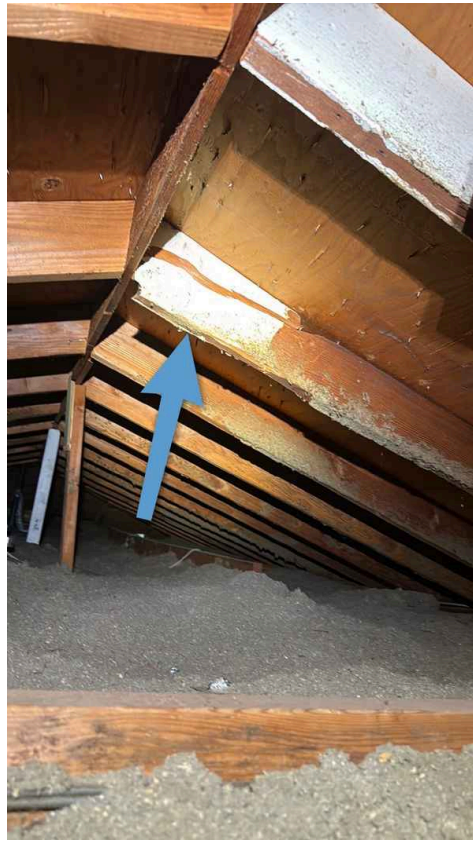
Right Attic

### 8.3.2 Roof & Attic Structure

#### **DAMAGED RAFTERS**

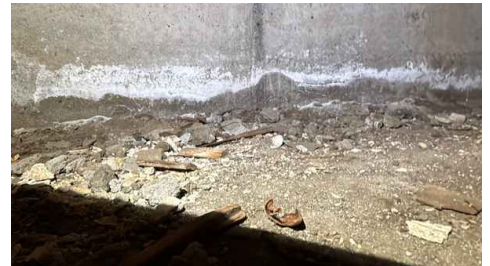
### EFFLORESCENCE

**Observation:** Efflorescence was noted on the wall surface, which is a white, powdery deposit consistent with moisture intrusion. This can lead to paint flaking, material deterioration, and potentially microbial growth.

**Likely due to downspouts, not discharging water away from the home at a safe distance.**

Recommendation

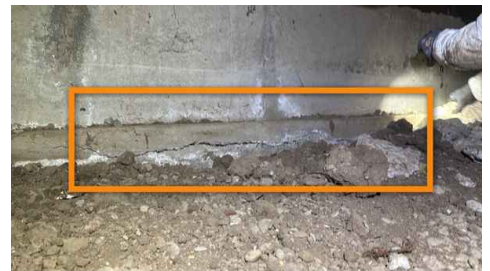
### MODERATE CRACK

Moderate cracks were observed in the foundation wall, which is a significant concern as it may indicate structural issues, potential shifting, or water intrusion.

**Recommendation:** evaluation by a foundation specialist is strongly advised to assess the severity and determine necessary repairs (such as epoxy injection, underpinning, or wall stabilization)

Contact a foundation contractor.

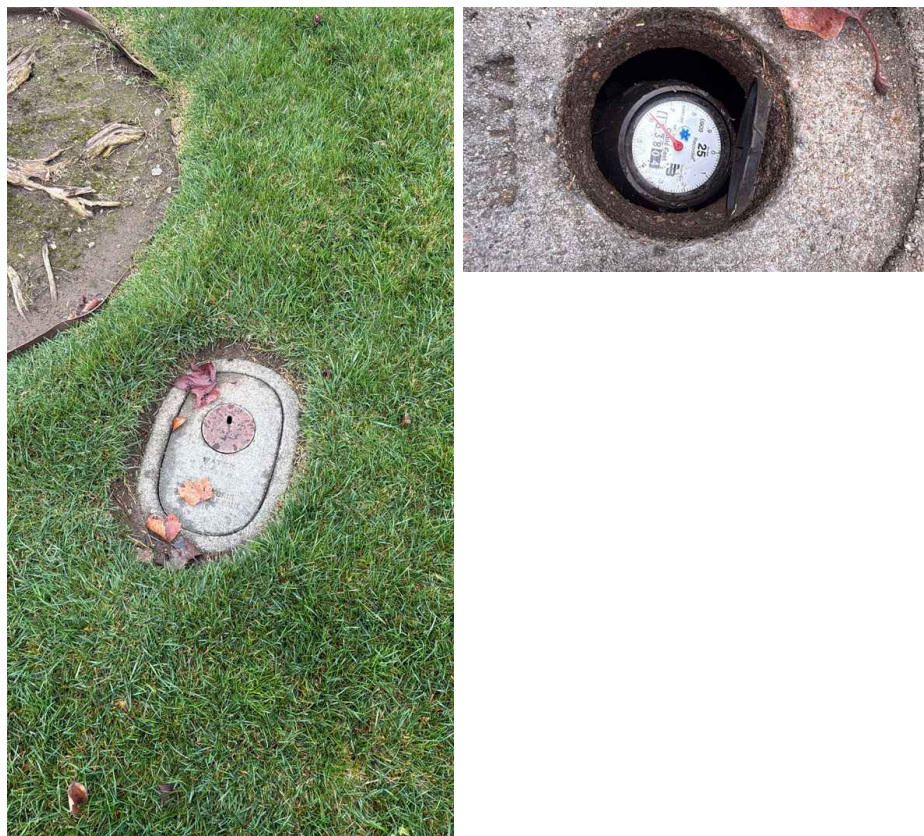
Front of house

Flow Meter measures the flow of water into residence.

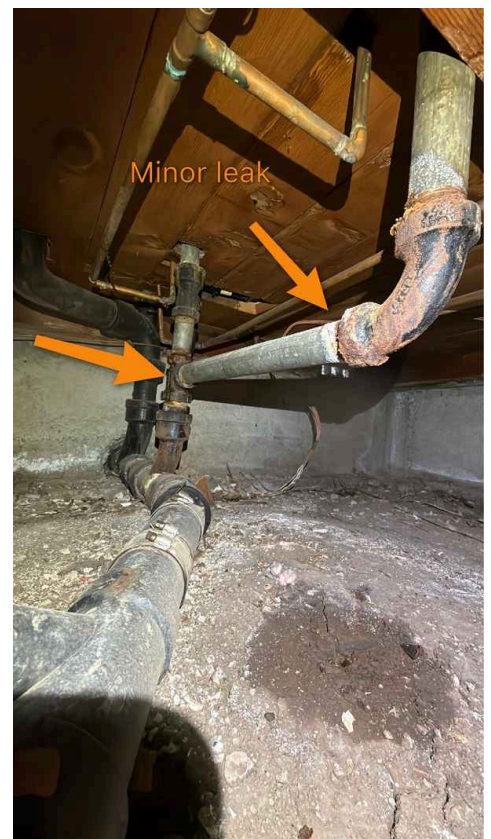
Front Crawlspace

### COMPONENT LEAK

**Observation:** A drain pipe or component showed signs of a leak.

**Recommendation:** It is recommended to have a qualified plumber evaluate and repair the leak soon, before use, to prevent further damage and ensure the system operates properly.

Contact a qualified plumbing contractor.

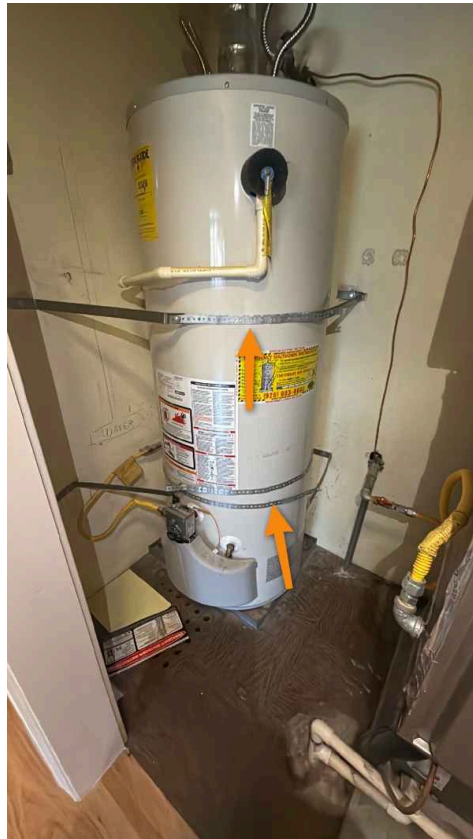
### IMPROPER SEISMIC STRAPPING

Improper seismic strapping increases the risk of equipment tipping over during an earthquake, leading to property damage, gas or water leaks, personal injury, and code violations. It can also result in failed inspections and denied insurance claims. To ensure safety, straps must be properly installed per local codes, securely anchored to studs or concrete, and tightened to prevent movement.

Contact a handyman or DIY project

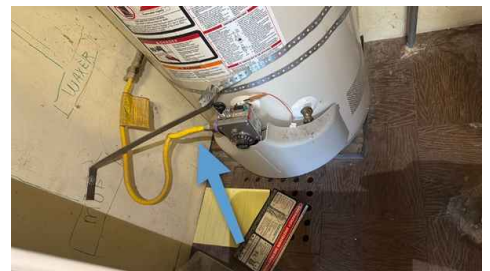
**MISSING SEDIMENT TRAP**

Gas line to water heater missing sediment trap.

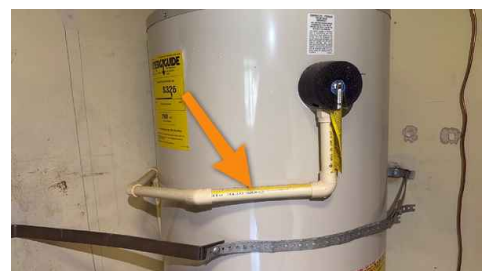
It is recommended a temperature pressure relief valve extension pipe be installed within 4 inches of the ground surface.

**Improper material copper piping is recommended not pvc.**

Contact a qualified HVAC professional.

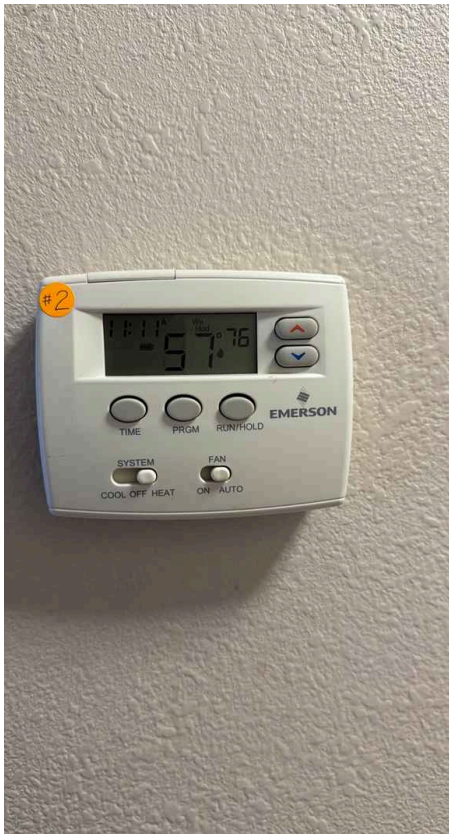
### Heating Equipment: Functional And Satisfactory

The unit was observed to be in overall functional and satisfactory condition with little or no deficiencies. Recommend servicing semiannually.

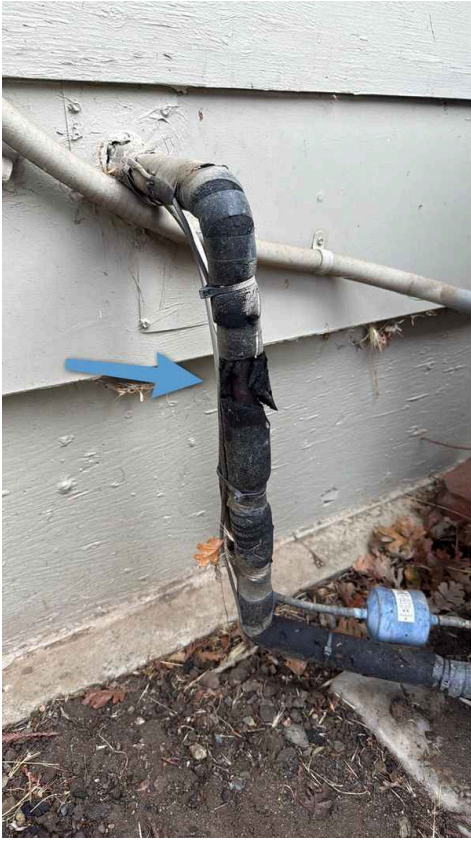
**Observation:** The AC unit's condensing lines lack proper insulation, risking condensation and reduced efficiency.

**Recommendation:** Wrap lines with foam insulation. Have an HVAC technician verify installation and performance.
