# FOREST PROPERTY INSPECTIONS

## PROPERTY INSPECTION

132 Cafeto Ct  
Walnut Creek, CA 94598

02/18/2026

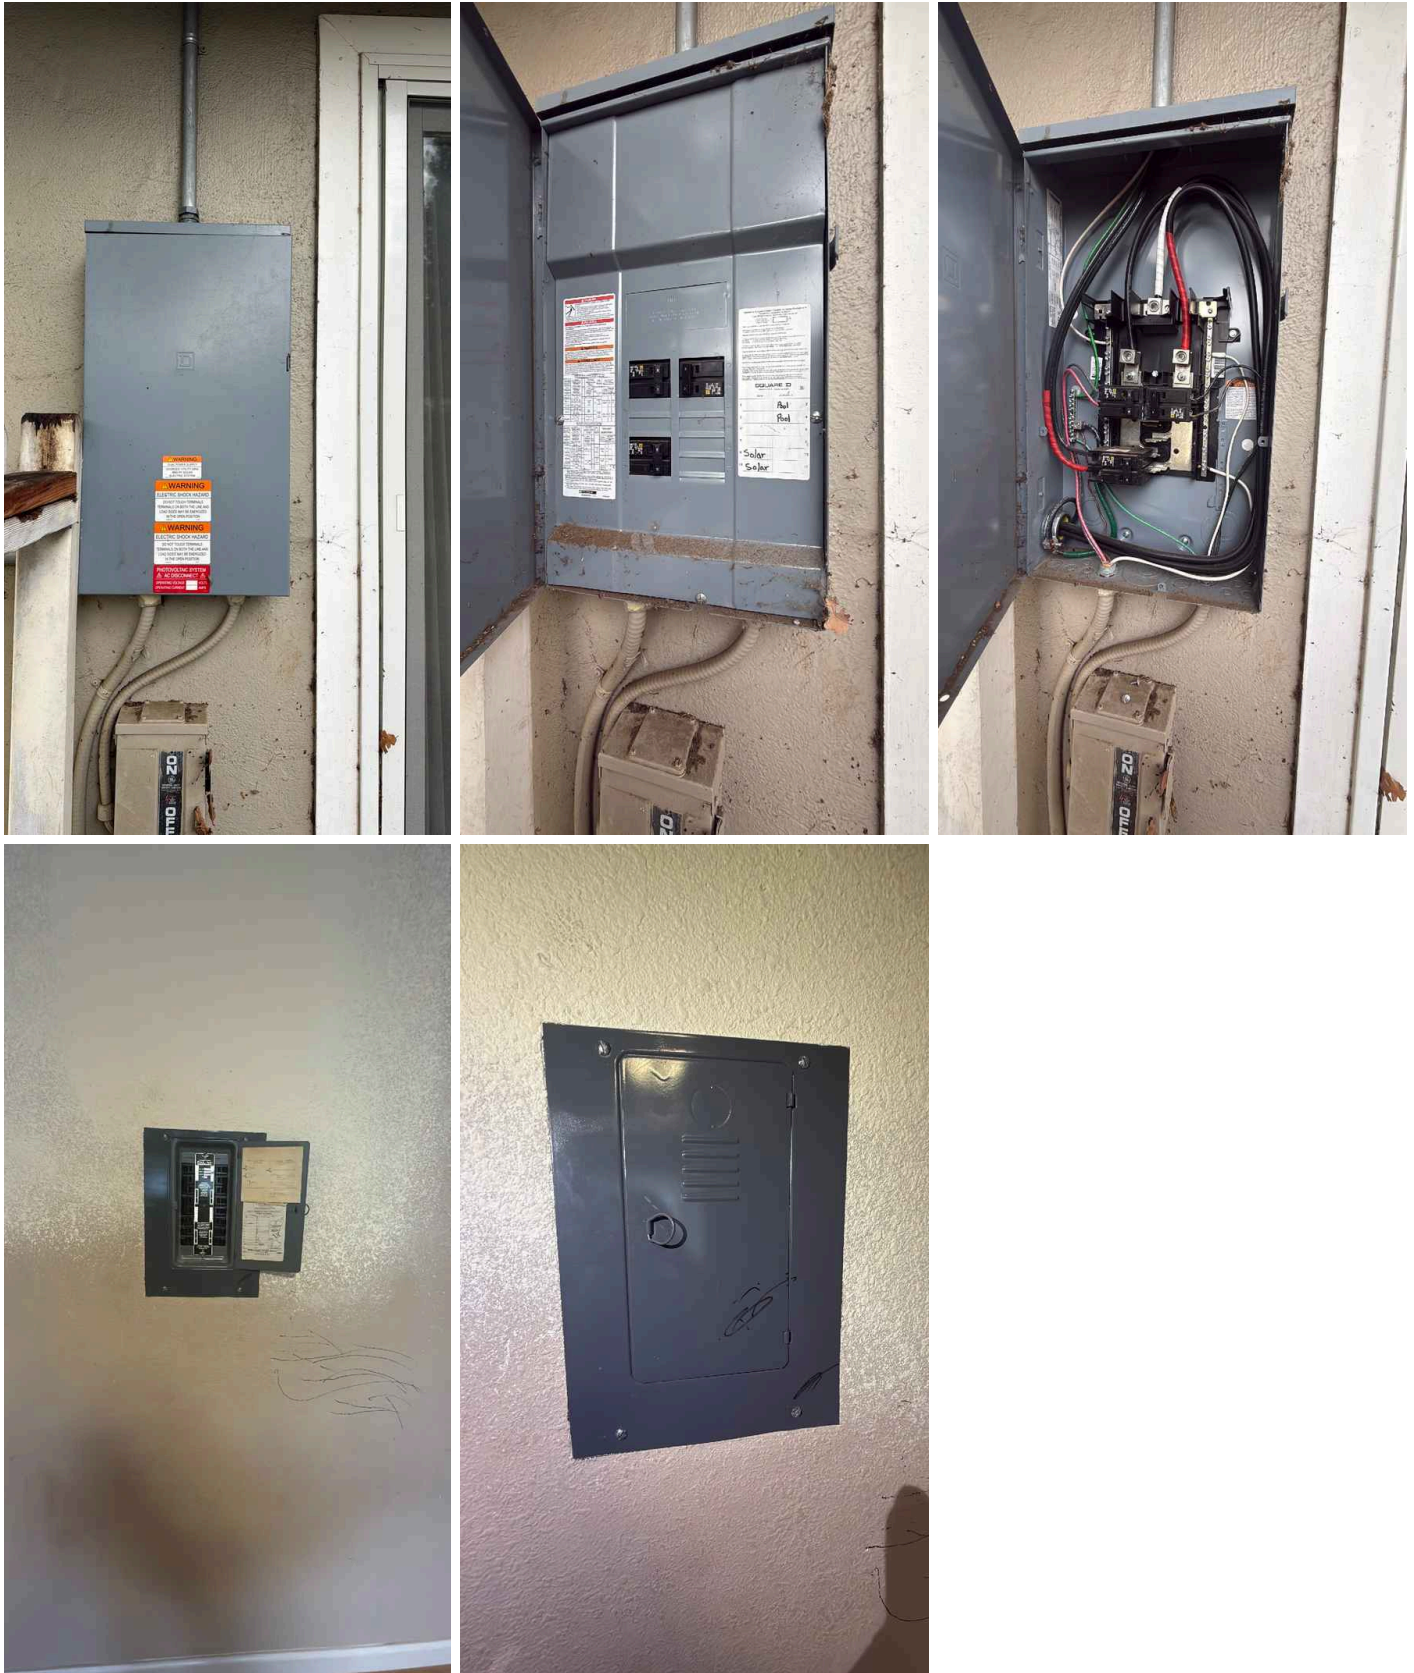
### Service/Main Disconnect and Subpanels: Satisfactory Condition

The exterior electrical service panel was observed to be in overall satisfactory condition with little or no deficiencies.

### Service/Main Disconnect and Subpanels: Sub Panel Location(s)

Exterior, Interior Room

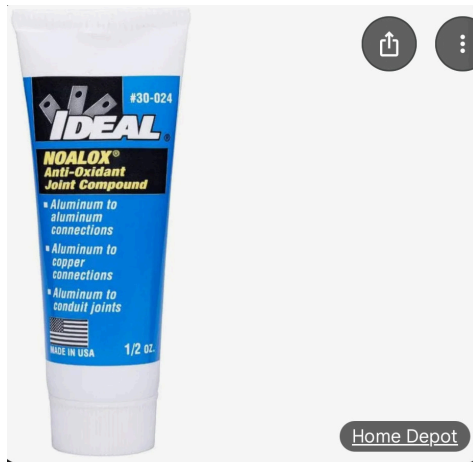
Service panel

The aluminum conductors observed in the electrical panel lack antioxidant paste, which is essential to prevent oxidation and ensure proper conductivity. It is recommended to apply an approved antioxidant compound to the connections to reduce the risk of overheating and improve electrical safety. A qualified electrician should address this issue.

Contact a qualified electrical contractor.

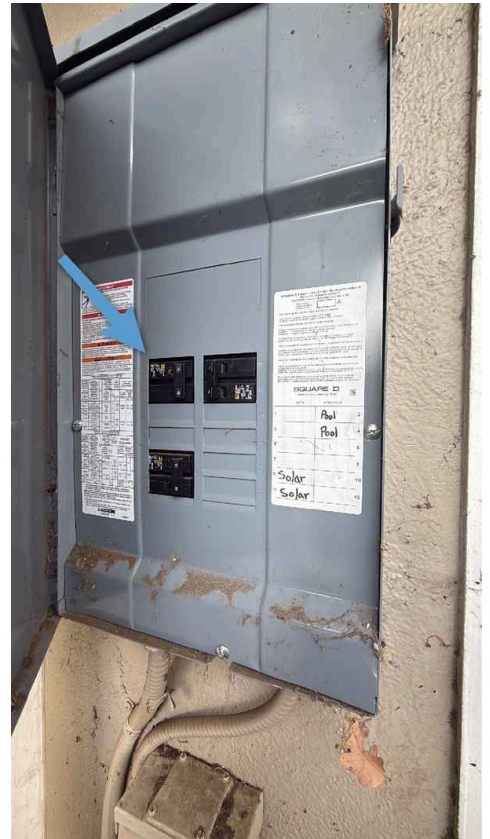
Exterior sub panel

### MISSING LABELS

**Observation:** The electrical panel is missing proper labeling, making it difficult to identify the circuits and their corresponding locations.

**Recommendation:** I recommend having a qualified electrician identify and label each circuit to improve safety, accessibility, and ease of troubleshooting.

Contact a qualified electrical contractor.

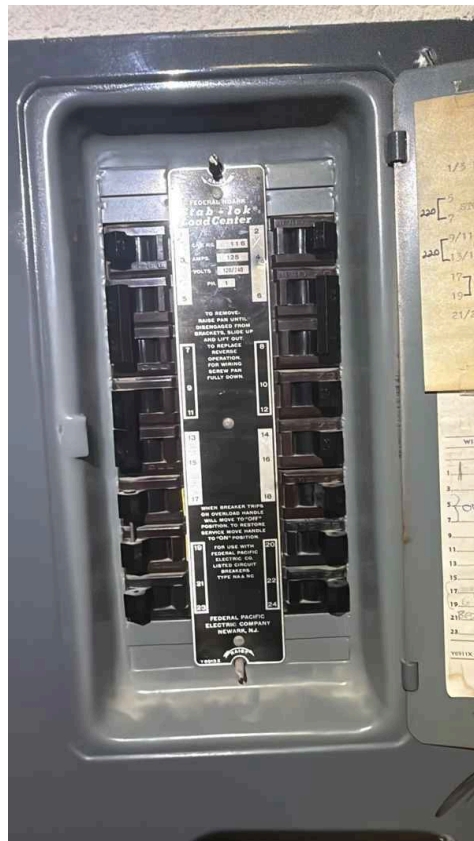
**Observation:** The electrical panel is a Federal Pacific brand, which is known for potential safety concerns, including defective breakers that may not trip during an overload or short circuit.

**Recommendation:** I recommend having a licensed electrician evaluate the panel and consider replacing it with a more reliable, code-compliant system to ensure safety.

**It's recommended once panel is upgraded that AFCI/GFCI circuit breakers are installed to remedy the open ground situation with various receptacles throughout the property.**

Contact a qualified electrical contractor.

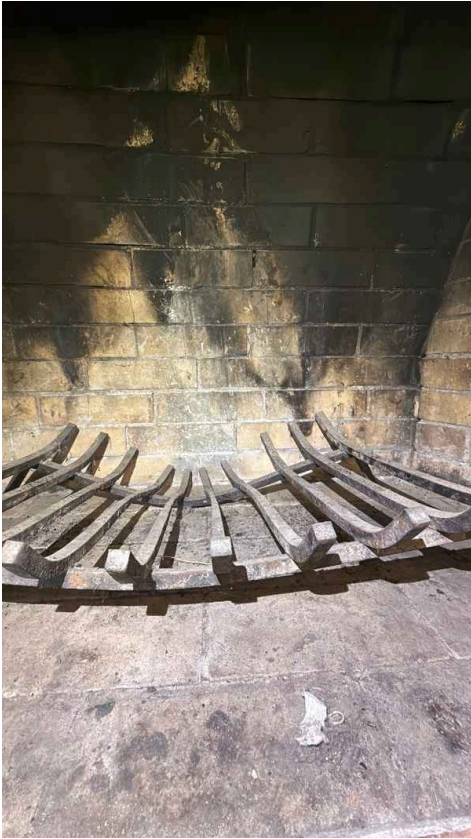
### **CRACKED MASONRY**

Some of the concrete or masonry components were cracked. I recommend a qualified contractor evaluate and repair properly.

Contact a qualified general contractor.

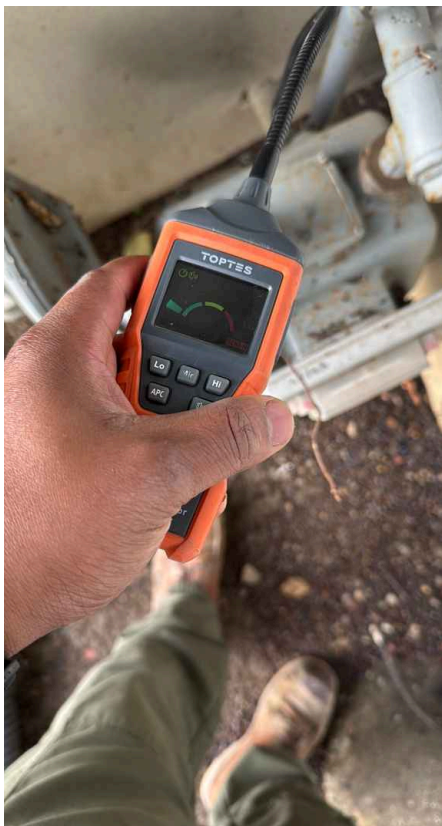
### Shut off Valve: No gas leak detected

At time of inspection, no gas leak was detected
